RE Official information request CDHB 9881 and WCDHB 9161

Condition Assessment of Hospital Buildings

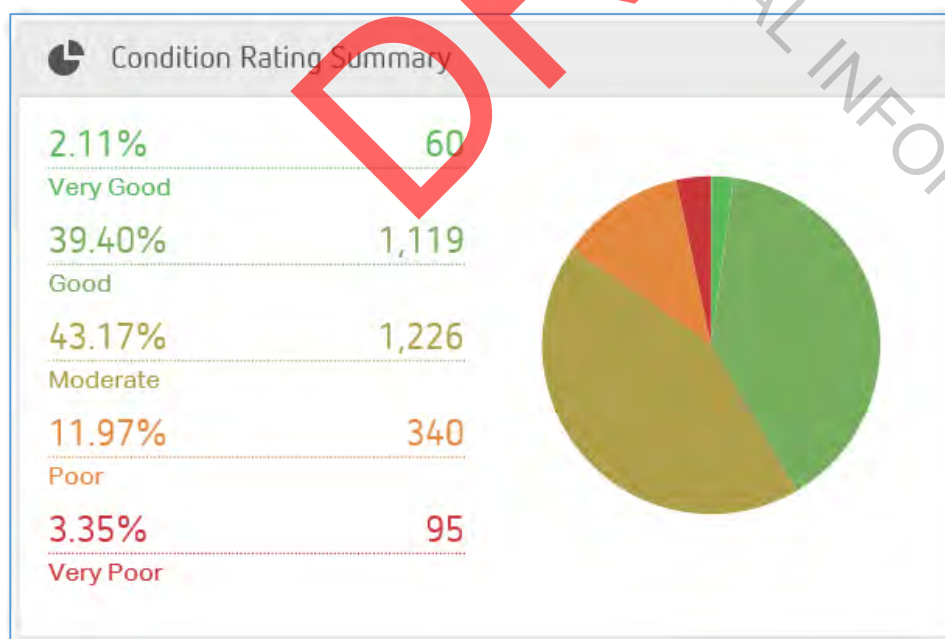
Figure 1 Overall site Condition Summary

The overall condition of all the assets surveyed is 2.8 out of 5. This includes external elevations, roofs and M&E plant.

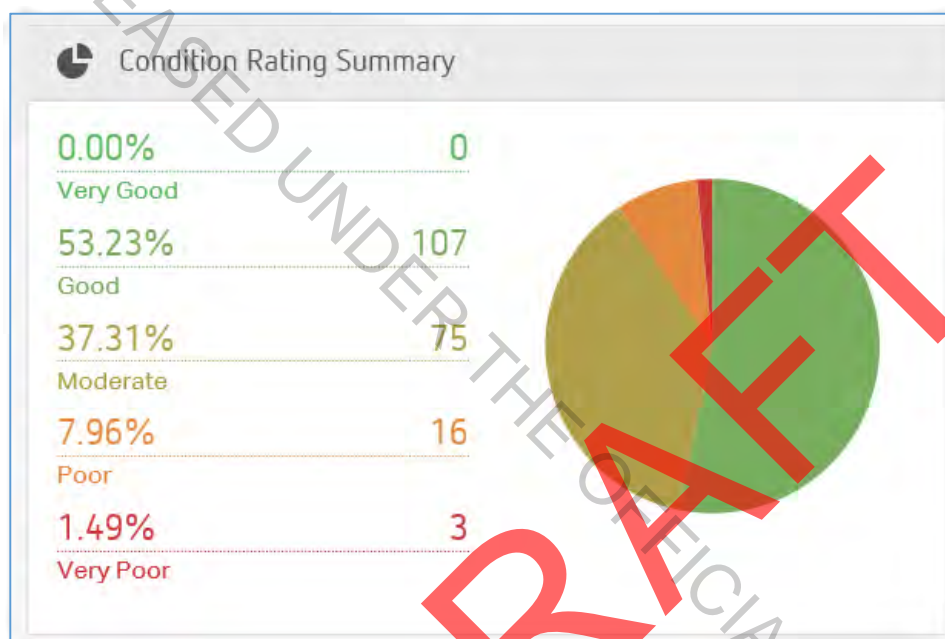
Figure 17 Building 3 Overall Condition

The building had significant alterations and extensions in 1999. The overall condition of the building is rated at 3.1.

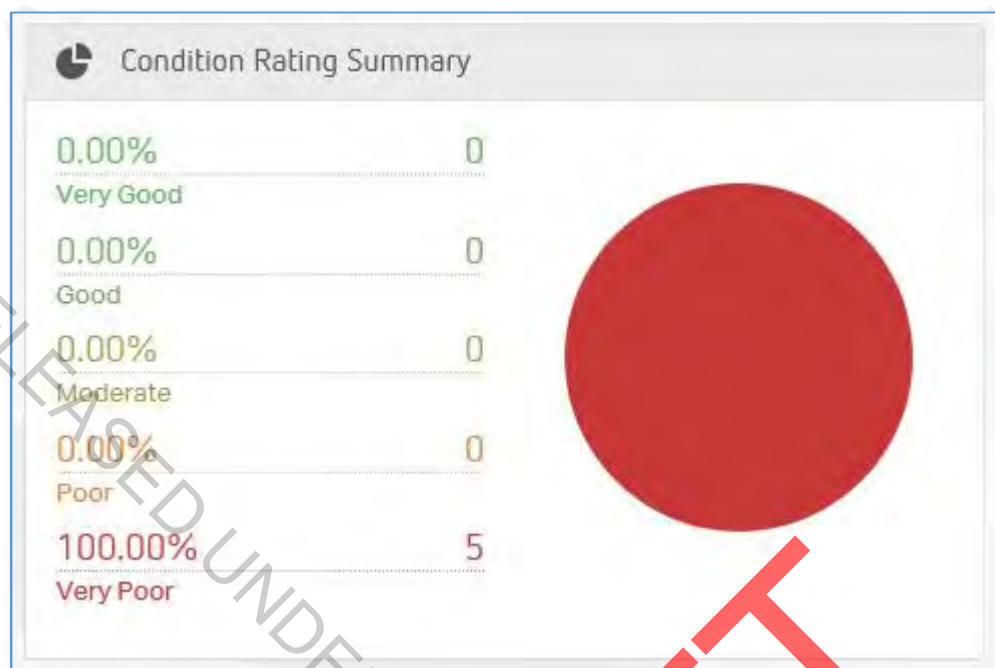
Figure 27 Building 4 Condition of Electrical Systems

The distribution switchboards and mechanical controls board servicing the building are of the same age as the main switchboard and similarly, replacements should be considered.

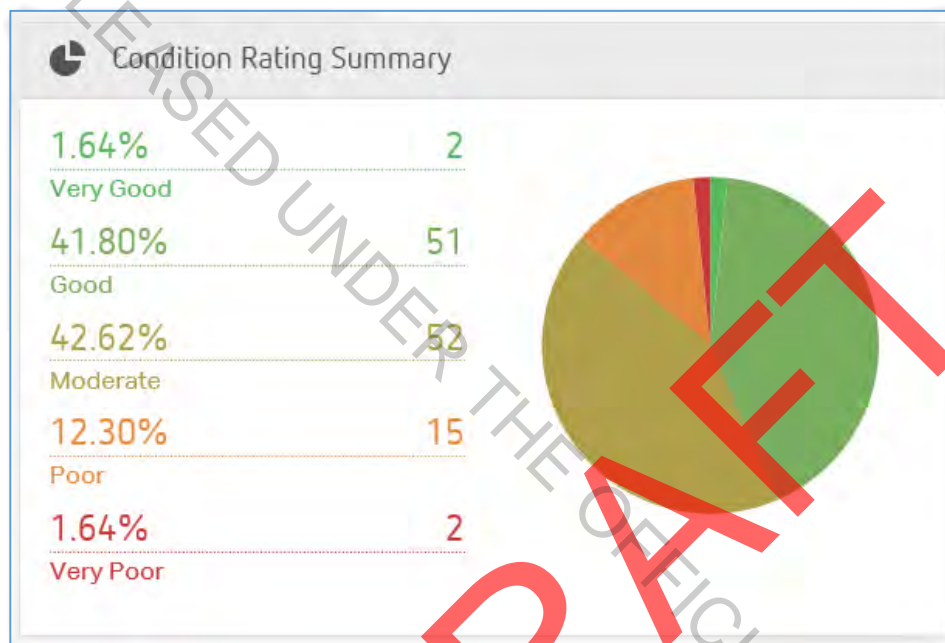
Figure 28 Building 5 Overall Condition

The overall condition of Building 5 is rated at 3.3.

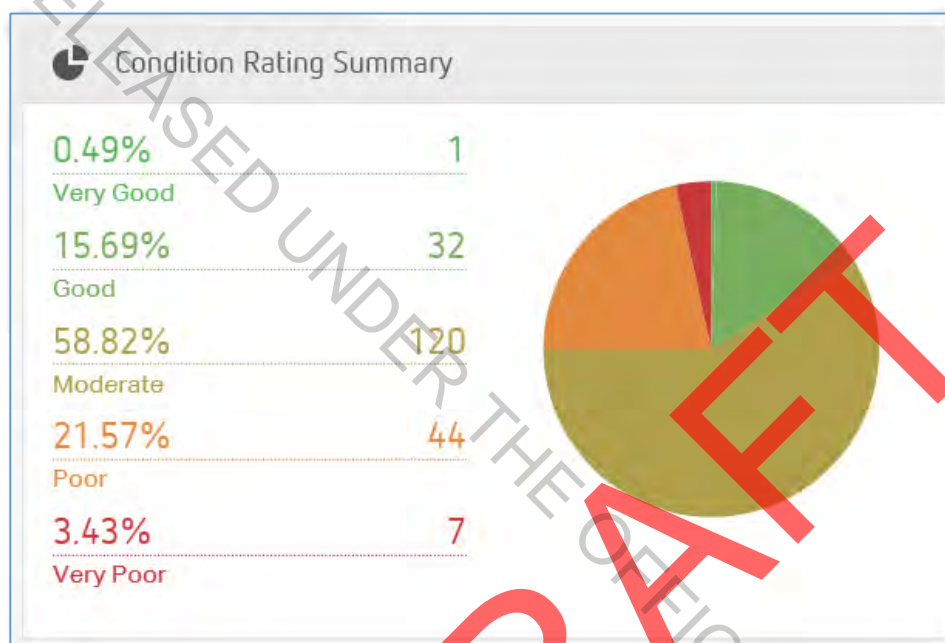
Figure 33 Building 6 Overall Condition

The building was constructed in 1930. It is timber framed with a weatherboard cladding system and has a corrugated iron roof. Modifications/extensions were made to the building around the years 1978, 1999 and further unknown dates. The building has predominantly timber framed windows. The overall condition of the building is rated at 3.1.

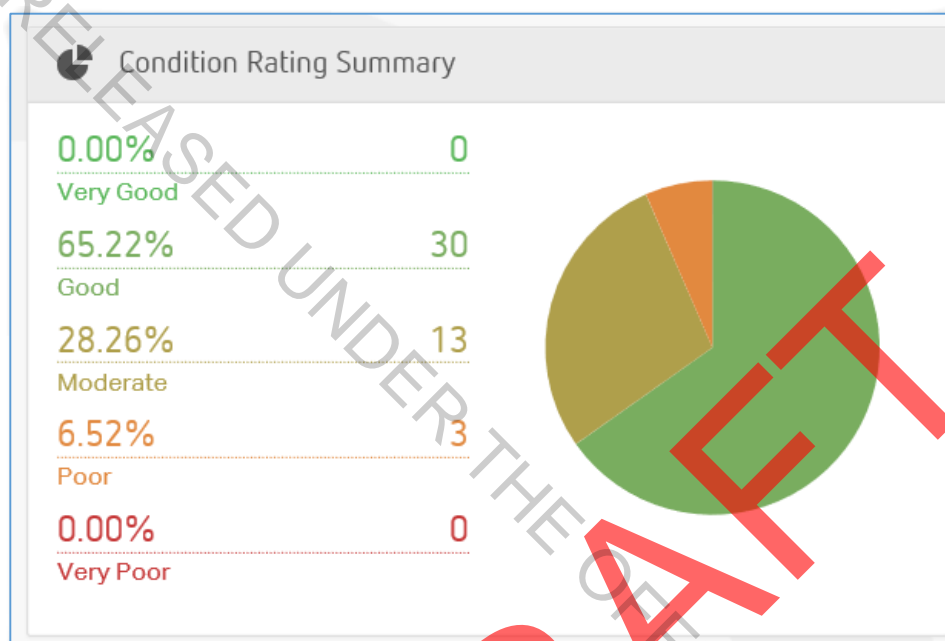
Figure 38 Building 7 Overall Condition

The building was constructed in 1998. It is a reinforced concrete and concrete block structure and has a Diamond V-Rib roof. The building has predominantly aluminium framed windows. The overall condition of the building is rated at 2.3.

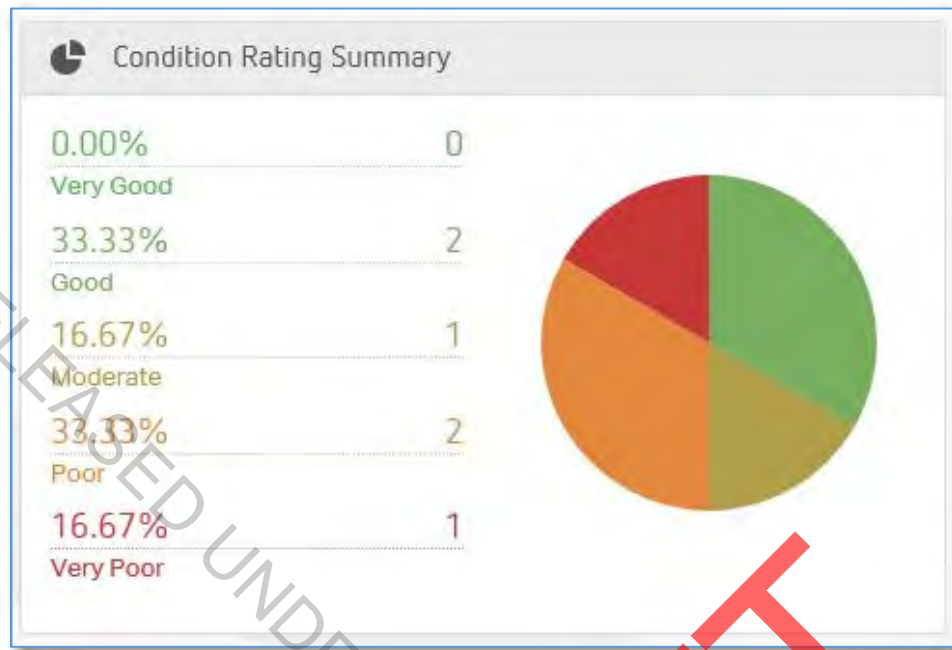
Figure 52 Building 9 Condition of Electrical Systems

The distribution switchboard in the Kitchen consists of old panels in moderate to poor condition.

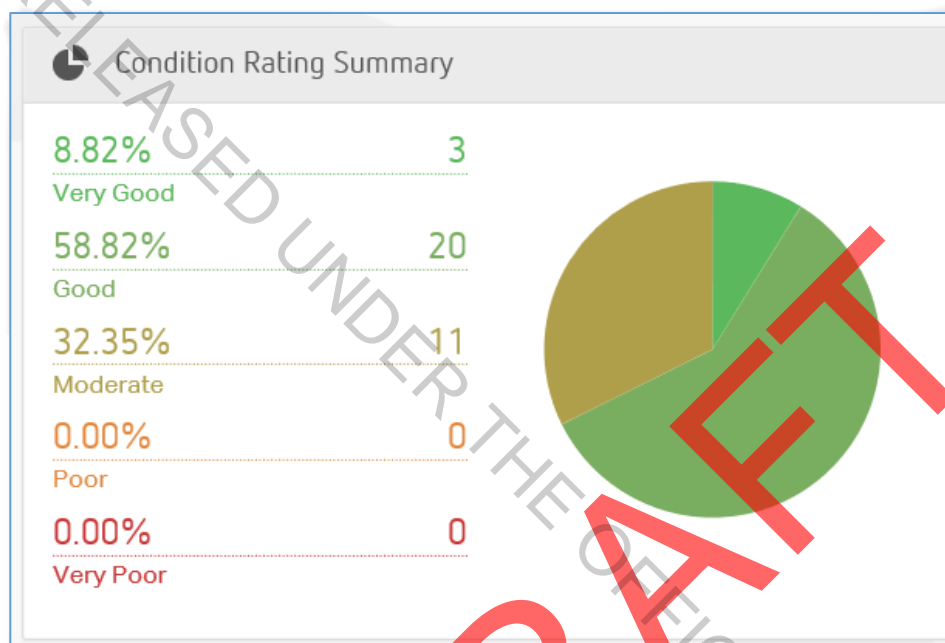
Figure 57 Building 13 Overall Condition

The overall condition of the building is rate at 1.6.

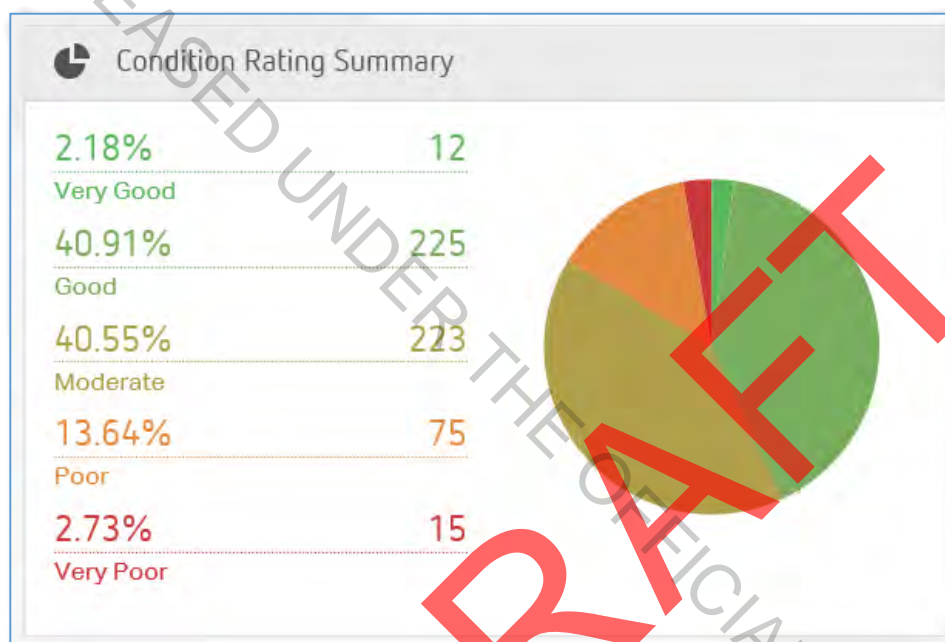
Figure 62 Building 10 Overall Condition

The overall condition of the building is rated at 2.9.

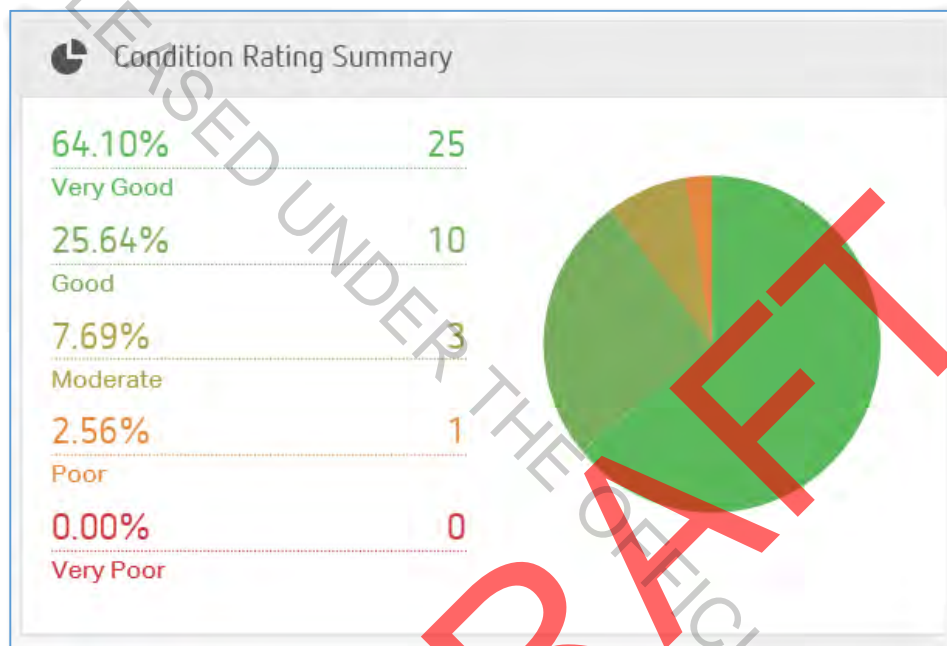
Figure 67 Building 16 Overall Building Condition

The overall condition of the building is rated at 1.5.

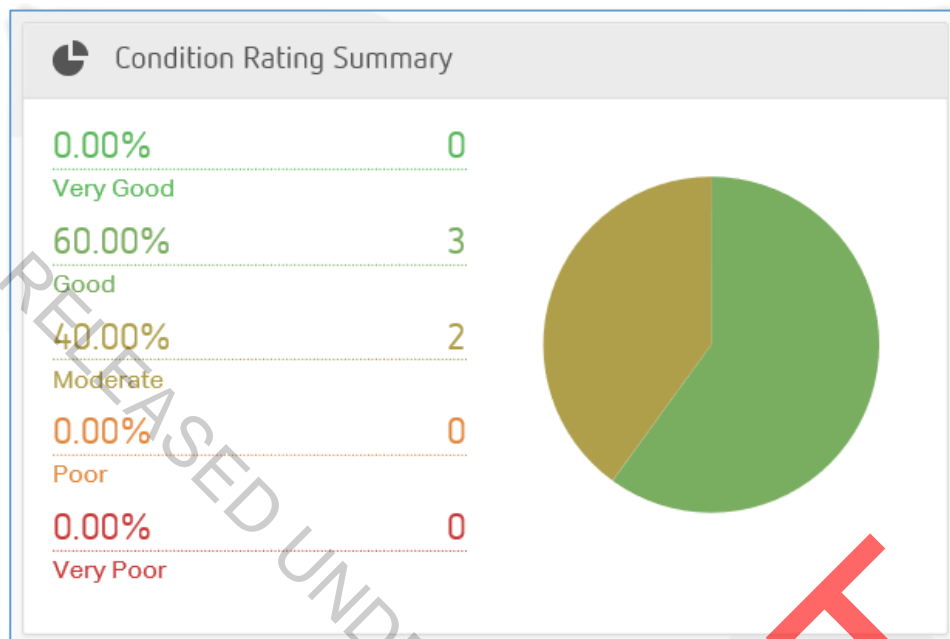
Figure 75 Building 21 Condition of Mechanical Systems

Domestic hot water is generated in an electric storage cylinder located in the cleaners' room G020. This is nearing the end of its service life and should be scheduled for replacement.

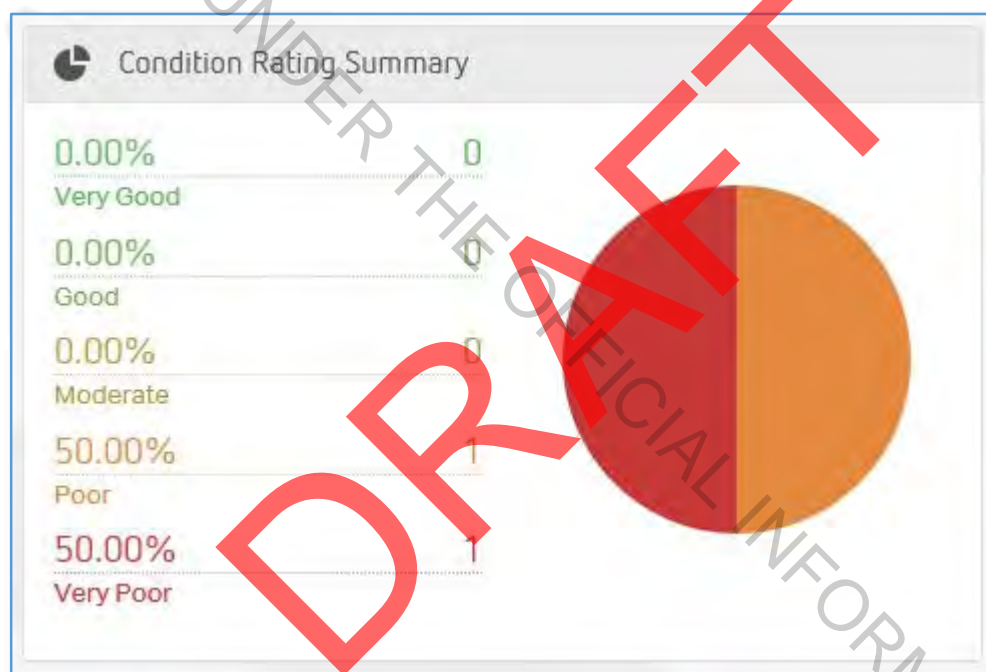
Figure 81 Building 22 condition of Electrical Systems

The distribution switchboards servicing Building 22 are of the same age as the main switchboard and similarly, a replacement should be considered.
