RE Official Information Act request WCDHB 9117

Mould remediation control plan for

Mould ID Report Haast Clinic

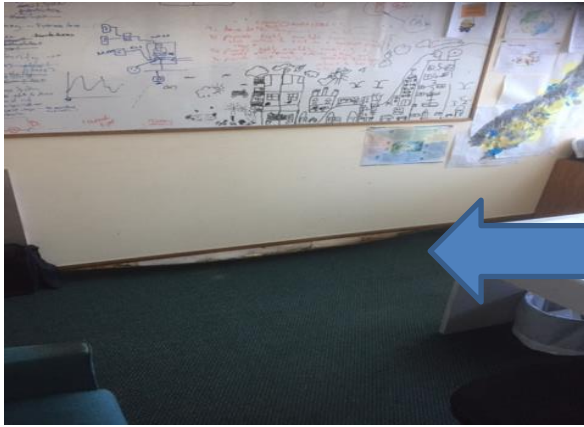
S09 IT Office

Stachybotrys Detected

- Removal of contaminated flooring and wall lining
- HEPA vacuum and sanitize full room of contents/structure

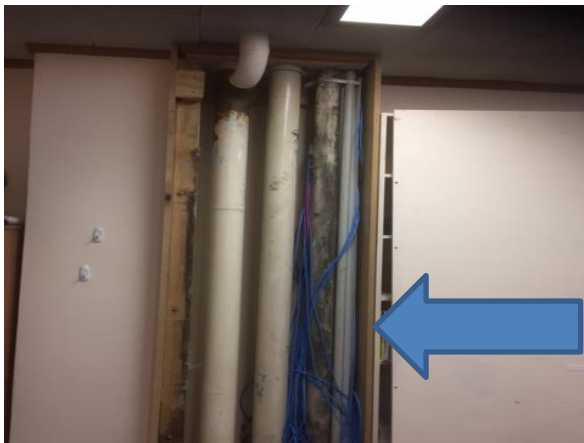
S15 Technicians Workshop

Cladosporium Detected

- Removal of contaminated flooring and wall lining
- HEPA vacuum and sanitize full room of contents/structure
