### **RE Official information request WCDHB 9438**

# Grey Base Hospital Acute and Community Mental Health Detailed Seismic Assessment

Project Number: 5-C4202.00  
22 June 2020

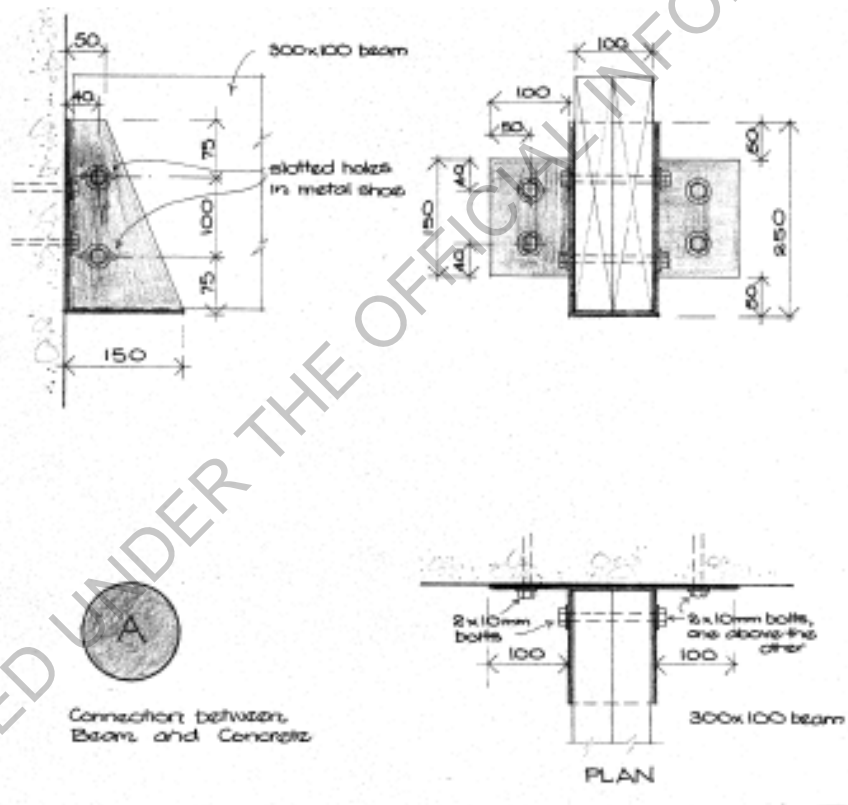
Figure 5: Connection between timber roof diaphragm and concrete walls

The perimeter of the building consists of reinforced concrete walls for the lower and upper levels. The walls are detailed as 250mm thick doubly reinforced concrete behaving as piers and spandrels due to the large number of openings. The walls were found to have sufficient capacity to satisfy the expected lateral demands, utilising nominal ductility. The concrete walls are well connected into the system at the roof diaphragm level as is shown below of the timber beam connection to concrete.

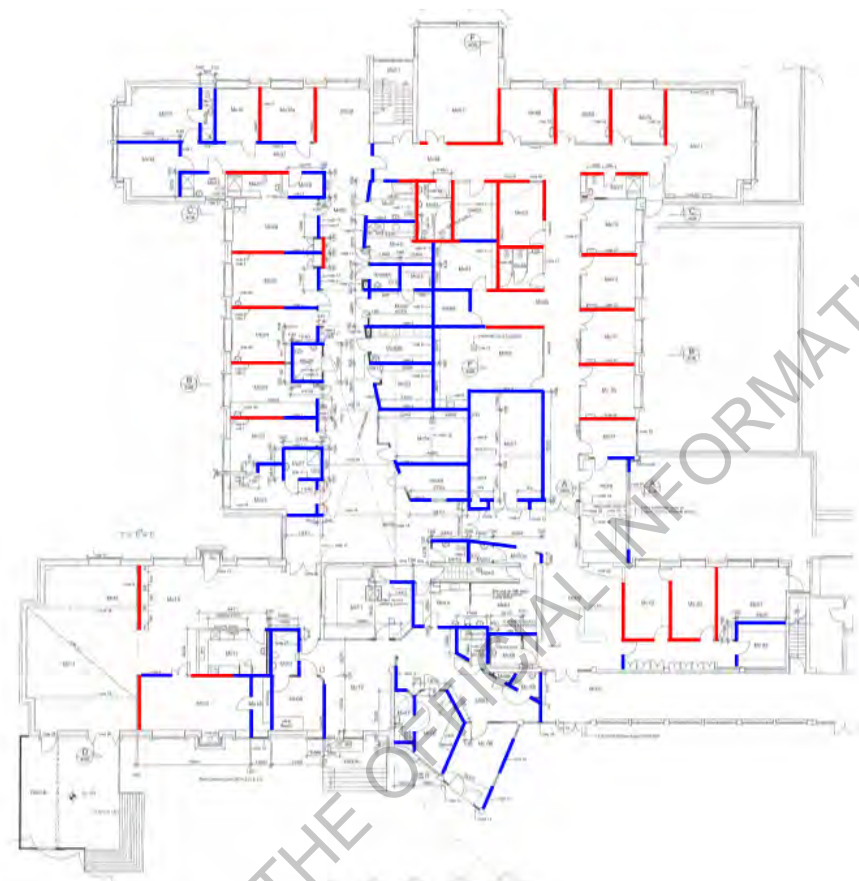
Figure 6: Timber bracing wall layout in the upper level

The upper level of the building was originally constructed with timber bracing walls forming the lateral load resisting system. Alterations were carried out to the layout of the upper level in 2000. Figure 6 shows the layout of the timber walls, with red indicating original walls and blue showing the additional walls from the alterations.

The original walls were designated as bracing elements in the construction drawings. However, the detailing of these elements is not entirely clear from the drawings.

The alterations removed a small portion of existing walls and more than doubled the length of wall provided in each direction. There is approximately 150m of timber wall in each direction on the upper level and the alterations detailed that all the walls were to be lined with 9.5mm Gib and designed to NZS 3604 requirements.

The bracing capacity per metre of wall is limited by the hold-down fixing at the base. Intrusive investigations in 2012 found the base plate fixing to be shot fired nails, which is an acceptable method as per the GIB Ezybrace system. Based on this, the bracing capacity was taken as 60BU/m, which then reduced by the appropriate factor due to the 2.7m stud height.

The force-based approach to assessing the walls considered the weight supported by the timber walls and ignored the concrete perimeter walls contribution and weight. Using a ductility factor of  $\mu=3$  and a structural performance factor of  $S_p=0.7$ , the timber walls had a minimum rating of 55% NBS (IL3) in the critical direction.

In order to achieve a seismic rating greater than 67%NBS (IL3), it is recommended to reline a selected amount of wall area with a material that contains a larger bracing capacity such as GIB Braceline and/or plywood.

Higher capacity hold-down fixings to the concrete floor would also be required for selected walls.

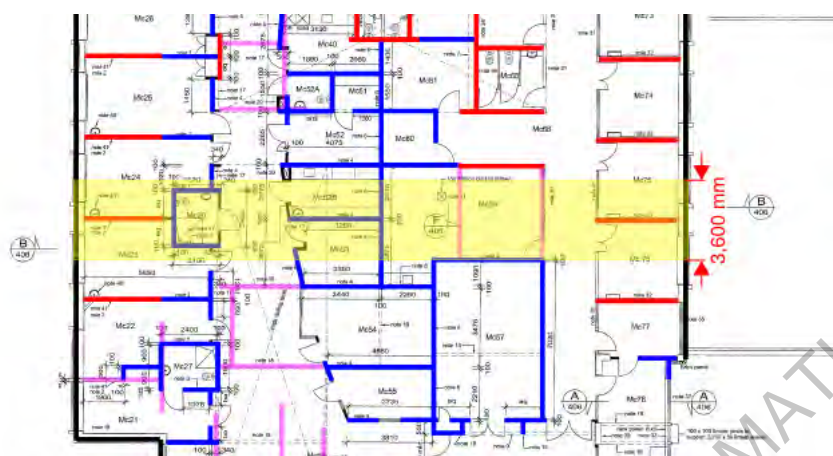
Figure 7: Strip of upper level assessed

In order to determine the combined response of the timber walls acting in conjunction with the concrete perimeter walls, a SLaMA assessment was undertaken to verify this result. This looked at a critical tributary strip of the upper level of the structure.

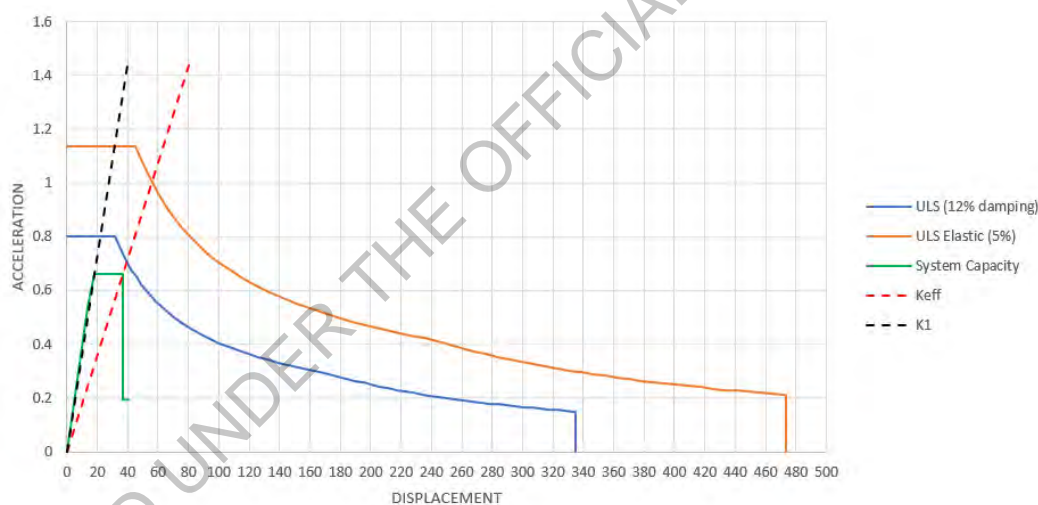
Figure 8: Combined system acceleration-displacement curve

The predicted acceleration-displacement responses of the concrete walls and timber walls are shown below. When plotted with the ADRS curve the resulting rating is slightly higher, at 60%NBS (IL3), than the force based assessment when comparing the capacity to the ULS elastic ADRS curve.

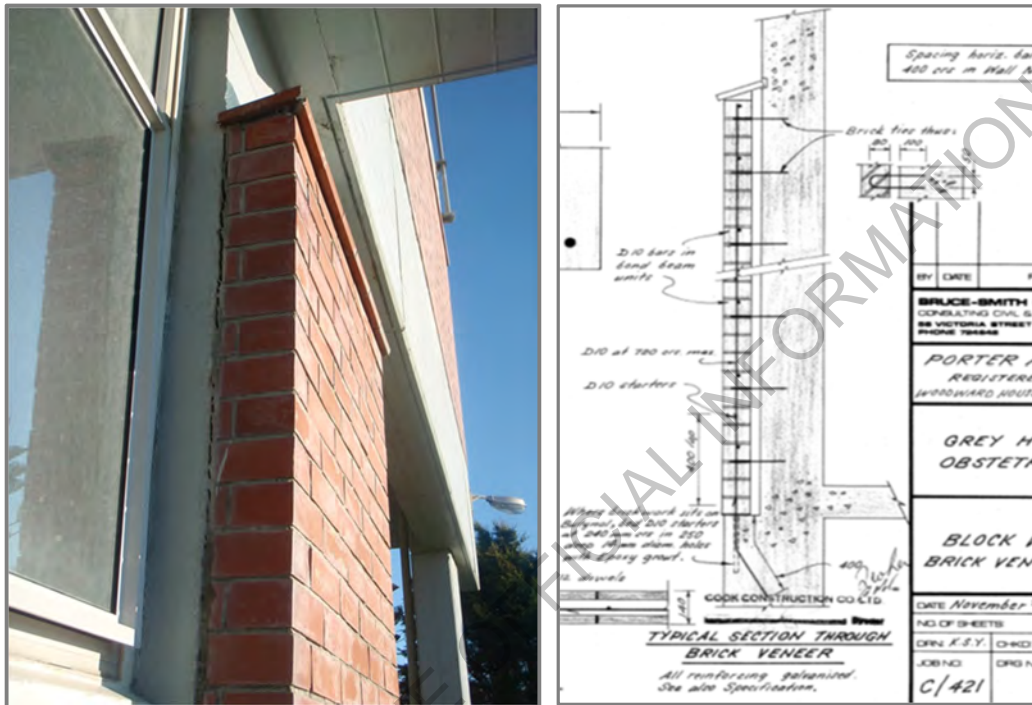
Figure 9: Gap between concrete pier and the brick veneer cladding- Lower Ground Level

A visual inspection in 2012 identified a few areas of the external brick veneer at lower ground level that appeared to have some minor movement or separation from the building.

The cause of the apparent movement and the condition of the ties in these locations should be investigated further.

The previous 2012 investigation noted some possible movement in a few isolated areas of the brick veneer cladding on the lower ground floor. Further investigation is recommended to determine the condition of the brick veneer ties to the supporting structure in the locations where there is apparent movement.
