RE Official information request WCDHB 9505

Grey Base Hospital Acute and Community Mental Health Detailed Seismic Assessment

Project Number: 5-C4202.00
30 April 2020

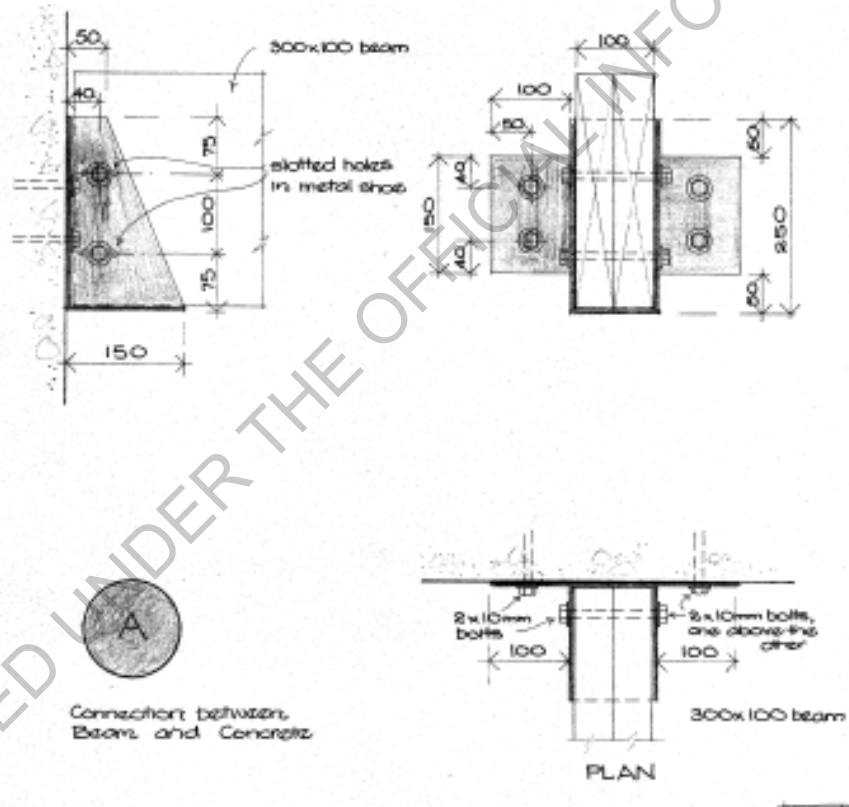
Figure 5: Connection between timber roof diaphragm and concrete walls

The perimeter of the building consists of reinforced concrete walls for the lower and upper levels. The walls are detailed as 250mm thick doubly reinforced concrete behaving as piers and spandrels due to the large number of openings. The walls were found to have sufficient capacity to satisfy the expected lateral demands, utilising nominal ductility. The concrete walls are well connected into the system at the roof diaphragm level as is shown below of the timber beam connection to concrete.

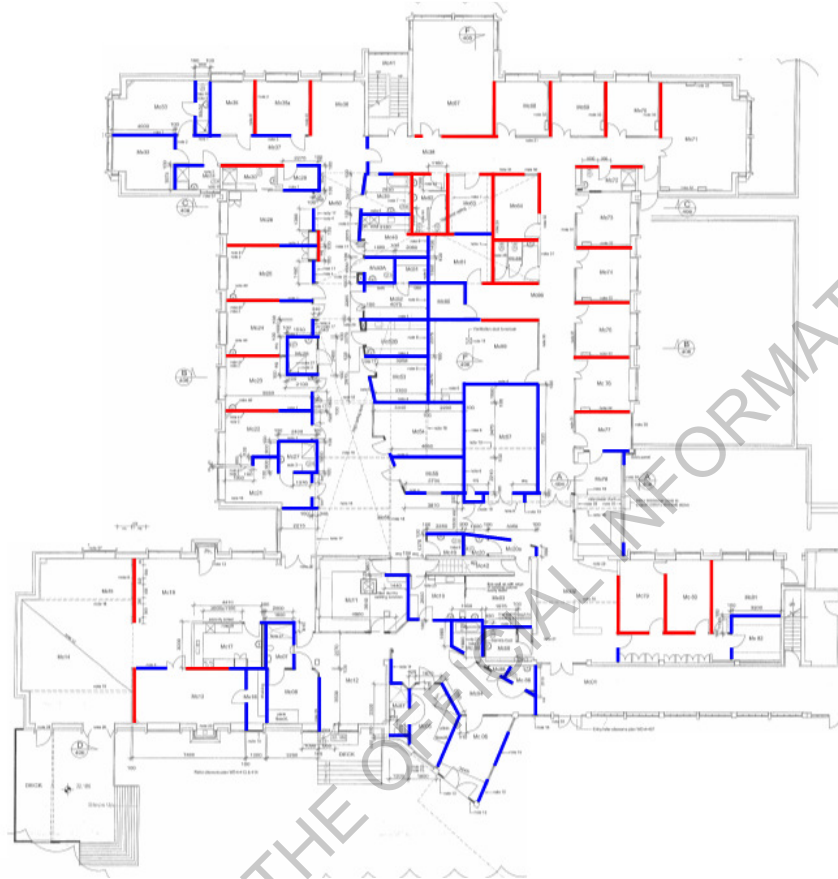
Figure 6: Timber bracing wall layout in the upper level

The upper level of the building was originally constructed with timber bracing walls forming the lateral load resisting system. Alterations were carried out to the layout of the upper level in 2000. Figure 6 shows the layout of the timber walls, with red indicating original walls and blue showing the additional walls from the alterations.

The original walls were designated as bracing elements in the construction drawings. However, the detailing of these elements is not entirely clear from the drawings.

The alterations removed a small portion of existing walls and more than doubled the length of wall provided in each direction. There is approximately 150m of timber wall in each direction on the upper level and the alterations detailed that all the walls were to be lined with 9.5mm Gib and designed to NZS 3604 requirements.

The bracing capacity per metre of wall is limited by the hold-down fixing at the base. Intrusive investigations in 2012 found the base plate fixing to be shot fired nails, which is an acceptable method as per the GIB Ezybrace system. Based on this, the bracing capacity was taken as 60BU/m, which then reduced by the appropriate factor due to the 2.7m stud height.

The force-based approach to assessing the walls considered the weight supported by the timber walls and ignored the concrete perimeter walls contribution and weight. Using a ductility factor of $\mu=3$ and a structural performance factor of $S_p=0.7$, the timber walls had a minimum rating of 55% NBS (IL3) in the critical direction.

In order to achieve a seismic rating greater than 67%NBS (IL3), it is recommended to reline a selected amount of wall area with a material that contains a larger bracing capacity such as GIB Braceline and/or plywood.

Higher capacity hold-down fixings to the concrete floor would also be required for selected walls.

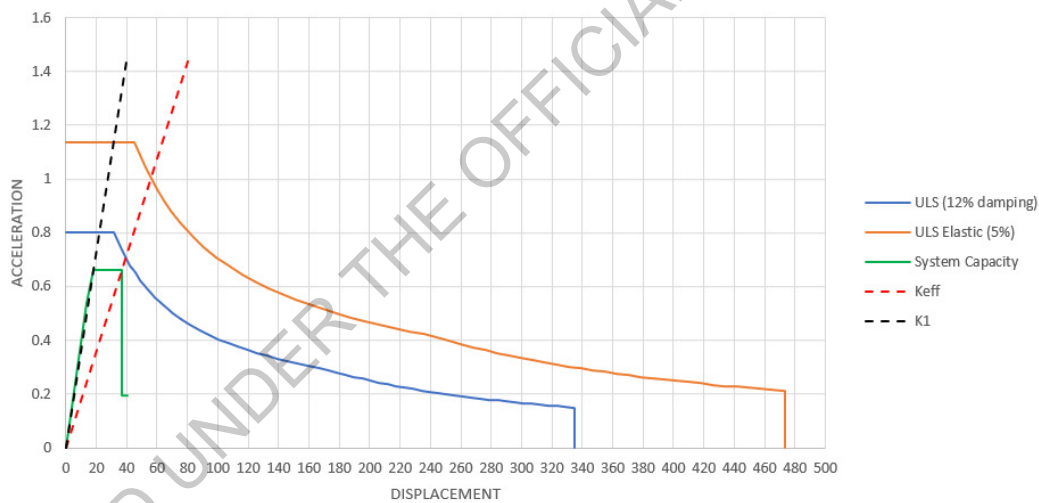
Figure 8: Combined system acceleration-displacement curve

The predicted acceleration-displacement responses of the concrete walls and timber walls are shown below. When plotted with the ADRS curve the resulting rating is slightly higher, at 60%NBS (IL3), than the force based assessment when comparing the capacity to the ULS elastic ADRS curve.

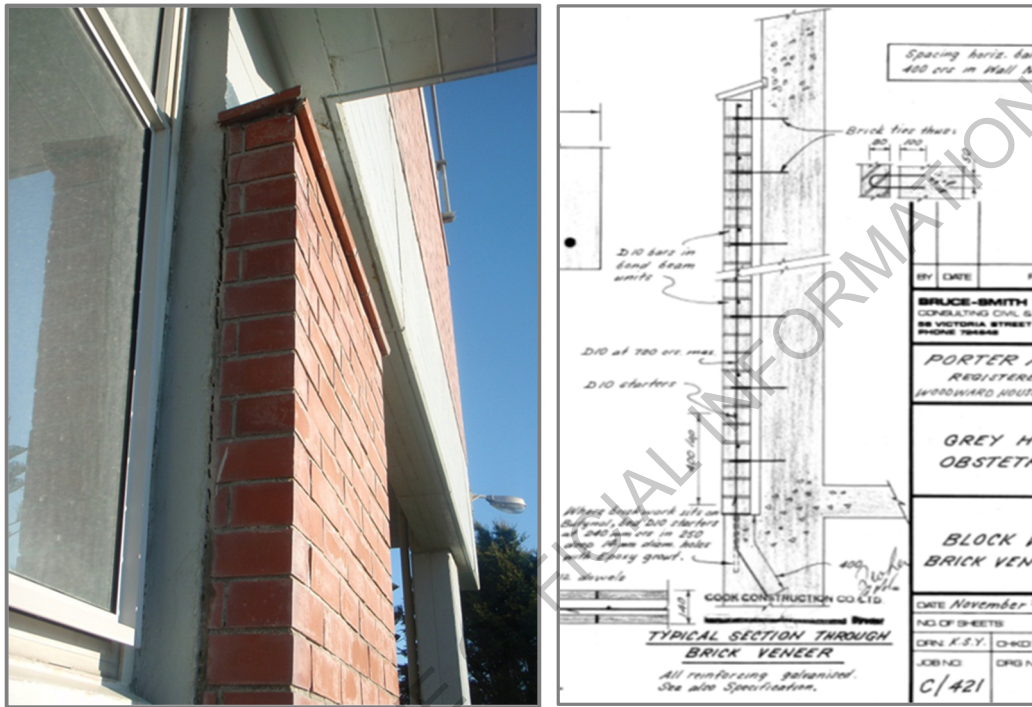
Figure 9: Gap between concrete pier and the brick veneer cladding- Lower Ground Level

A visual inspection in 2012 identified a few areas of the external brick veneer at lower ground level that appeared to have some minor movement or separation from the building.

The cause of the apparent movement and the condition of the ties in these locations should be investigated further.

The previous 2012 investigation noted some possible movement in a few isolated areas of the brick veneer cladding on the lower ground floor. Further investigation is recommended to determine the condition of the brick veneer ties to the supporting structure in the locations where there is apparent movement.
