RE Official information request CDHB 9881 and WCDHB 9161

Condition Assessment of Hospital Buildings

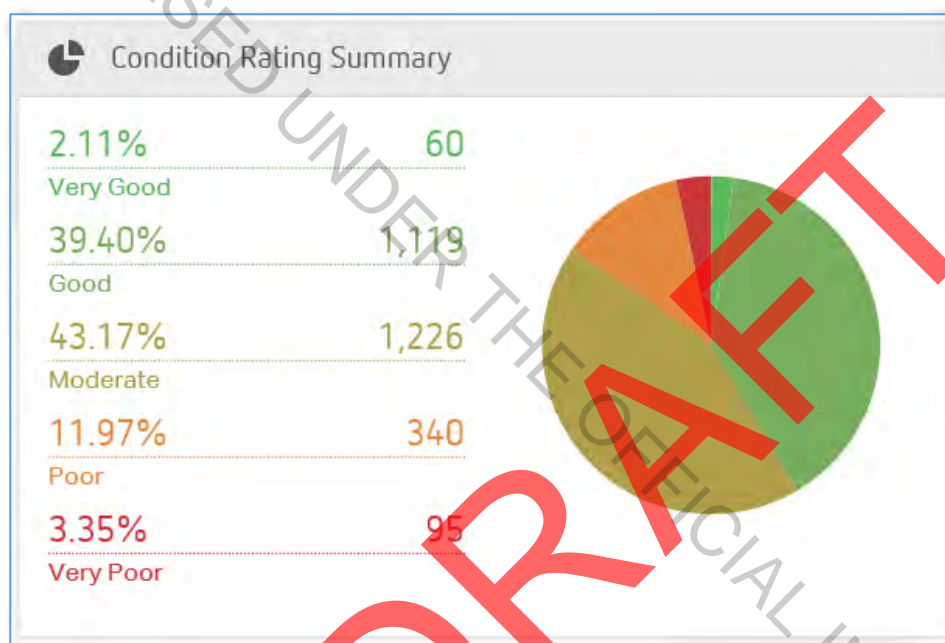
Figure 2 Overall site Condition Summary

The overall average condition of all the assets surveyed is 2.8 out of 5.

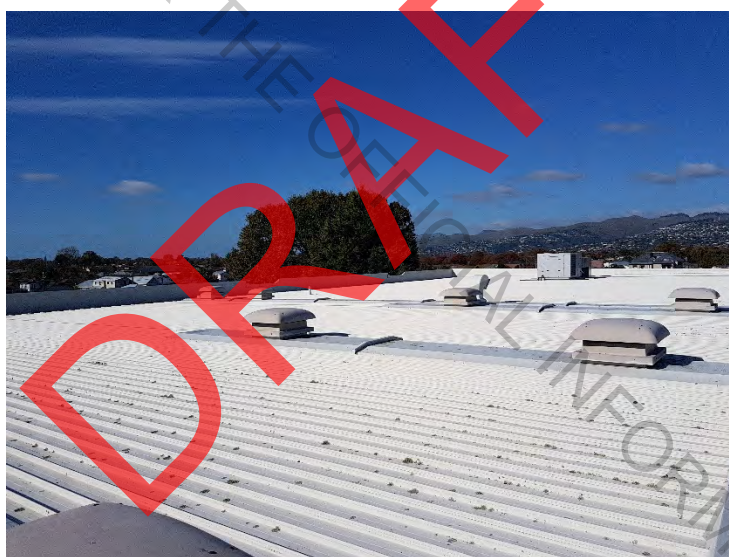
Figure 5 Large flat roof area identified in the Laundry Services Building

During our site visit, we found there were multiple roof areas that could be substandard for snow loads, as shown in Figure 4. Of these buildings, we are particularly concerned about the roof in the laundry building (Figure 5) and the canopy structure in the pre-school, due to the large spans and relatively flat roofs. The canopy structure in the pre-school is likely to be unconsented and the large spans were observed to be significantly under designed. The buildings of concern include:

We recommended carrying out an assessment to check the capacity of these roofs as highlighted in Figure 4 due to the increase in snow loads, especially the laundry building and pre-school canopy structure.

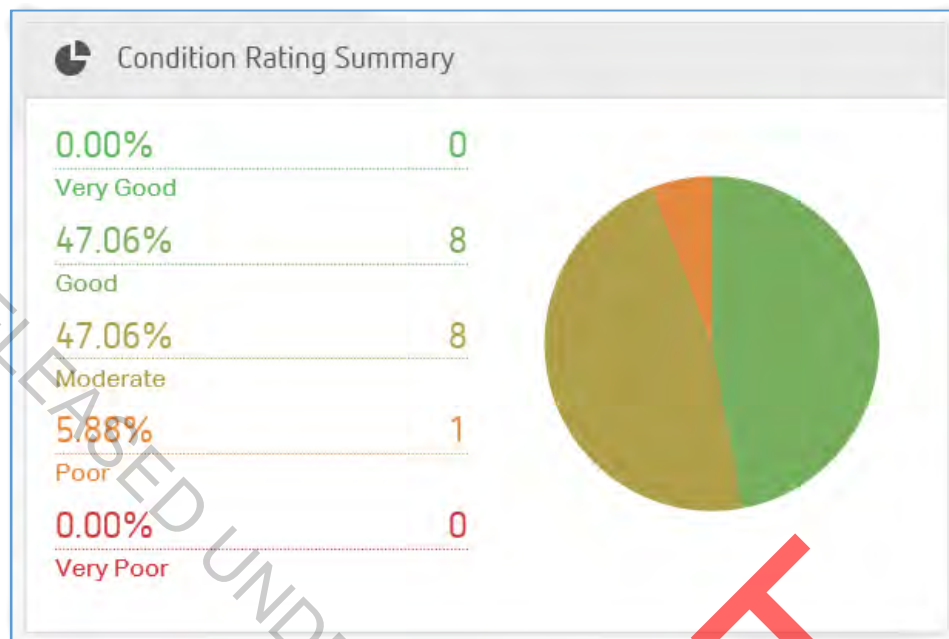
Figure 10 Building 1 Condition of Mechanical Systems

Heating plant appears to be well-maintained with no apparent issues requiring immediate attention. The mechanical plant generally including the primary heating water pump, calorifier pump, calorifier, chiller and air handling unit are into the second half of their service life and will exhibit increasing maintenance costs over the next ten years. Heating water zone pumps and domestic hot water circulation pump appear to have been replaced more recently and should have more than ten years expected service life remaining.

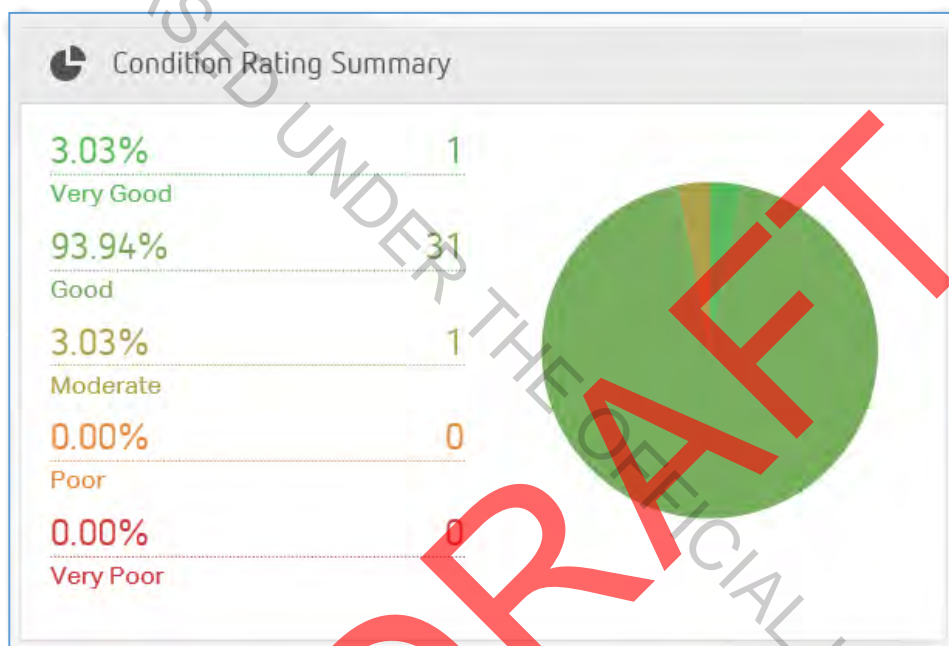
Figure 15 *Building 2 Condition of Mechanical Systems*

The mechanical plant: pumps, chiller, calorifier, heat exchangers, are in the first half of their service life and should have an expected remaining service life of over ten years.

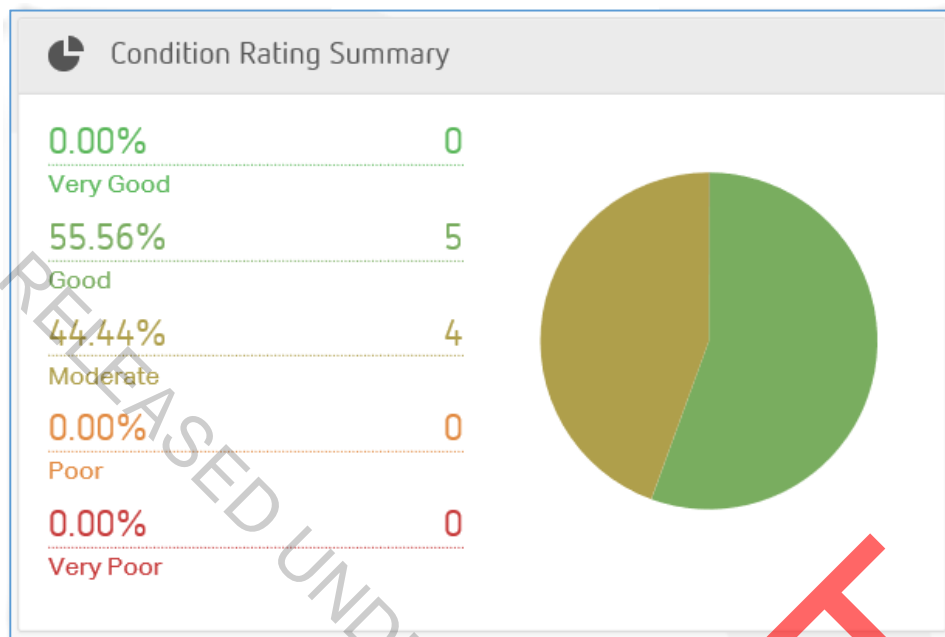
Figure 31 Building 5 Condition of Mechanical Services

The mechanical plant generally including the heat exchanger and calorifier are in the second half of their service life and will exhibit increasing maintenance costs over the next ten years. The mechanical control panel is original building equipment and should be replaced along with other electrical boards.

Pumps: heating water circulation, LTHW, and domestic hot water circulation pumps appear to have been replaced more recently and should have more than ten years expected service life remaining.

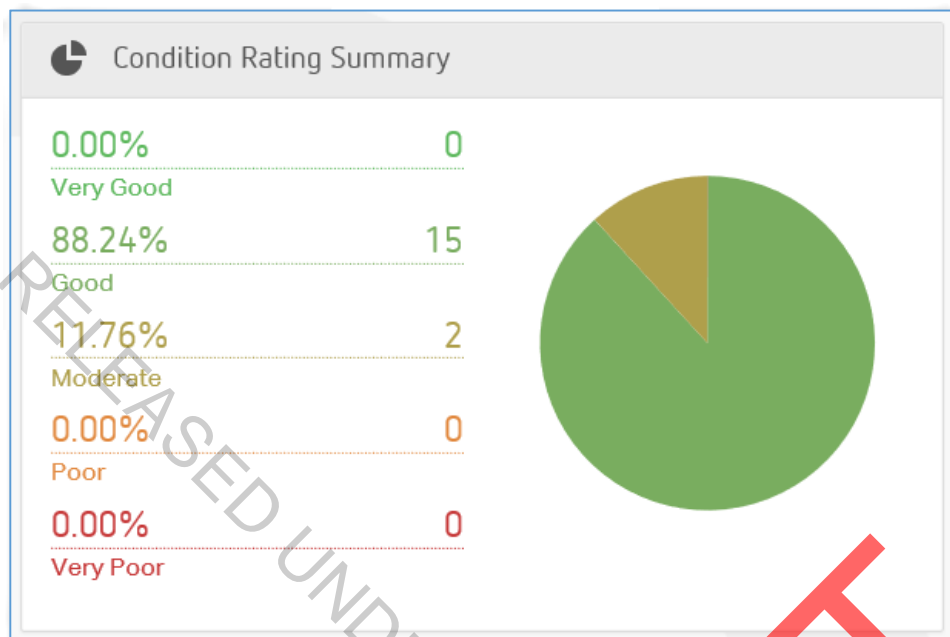
Figure 41 Building 7 Condition of Mechanical Services

Heating is provided by two boilers. The Binder wood chip boiler is equipped with particulate emission controls to meet the resource consent particulate discharge requirements. The other Hoval boiler is LPG-fired. The energy centre also houses associated plant: pumps, expansion tanks, buffer tank.

The energy centre was refurbished with the installation of the wood chip boiler and has been in service approximately six years of an expected twenty year service life.

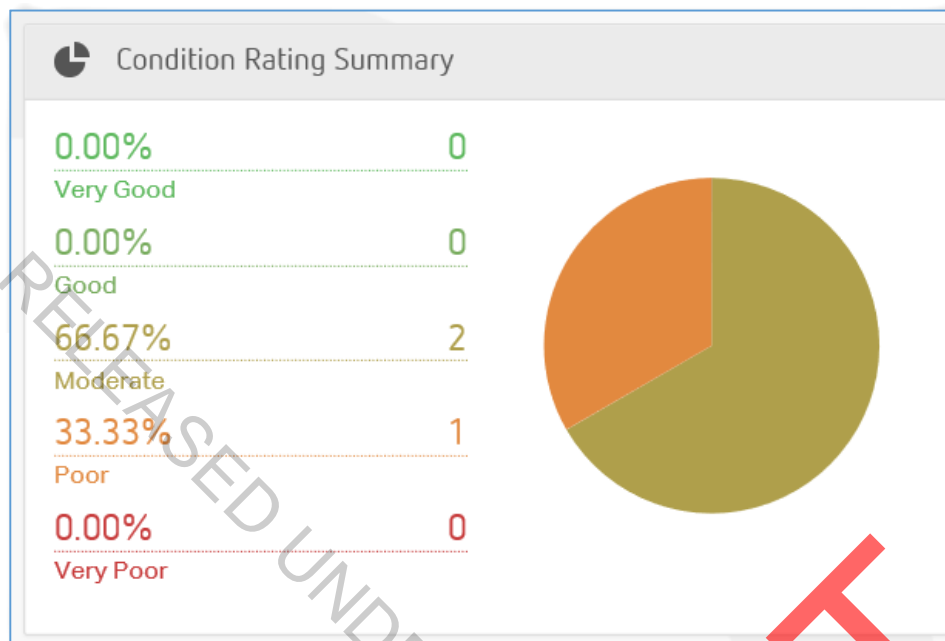
Figure 50 Building 9 Condition of Roof

- Areas of roof paint in very poor condition
- Downpipes in poor condition
- Internal gutters draining to flat roofing appears to be the cause of roof leaks

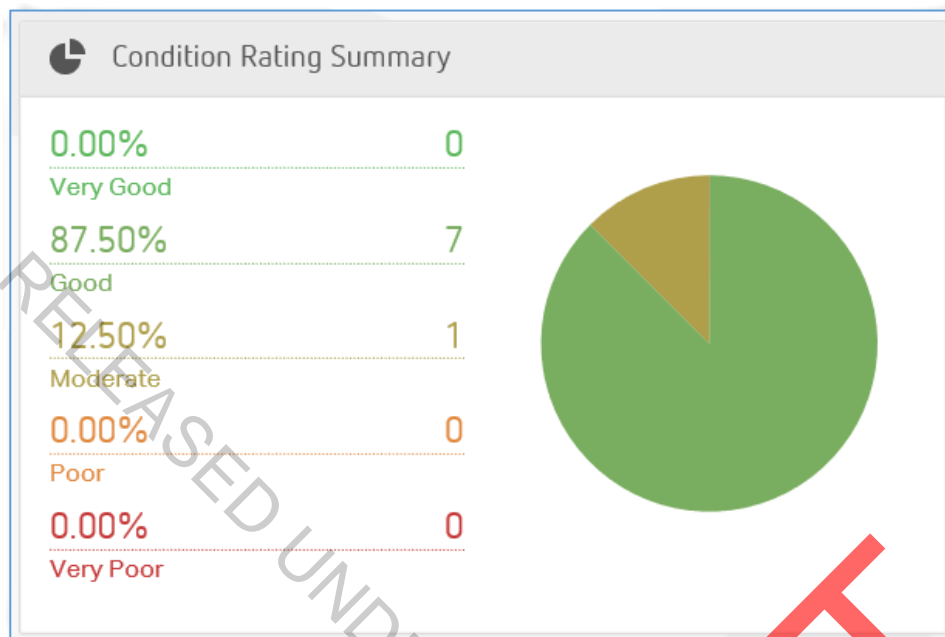
Figure 51 Building 9 Condition of Mechanical Systems

The mechanical plant generally including the pumps and the heat exchanger are in the first half of their service life and should have more than ten years expected service life remaining.

The mechanical control panel is of an age that it should be replaced when other electrical work is scheduled for the building.

The mechanical control panel replacement should be scheduled for within a five year time frame.

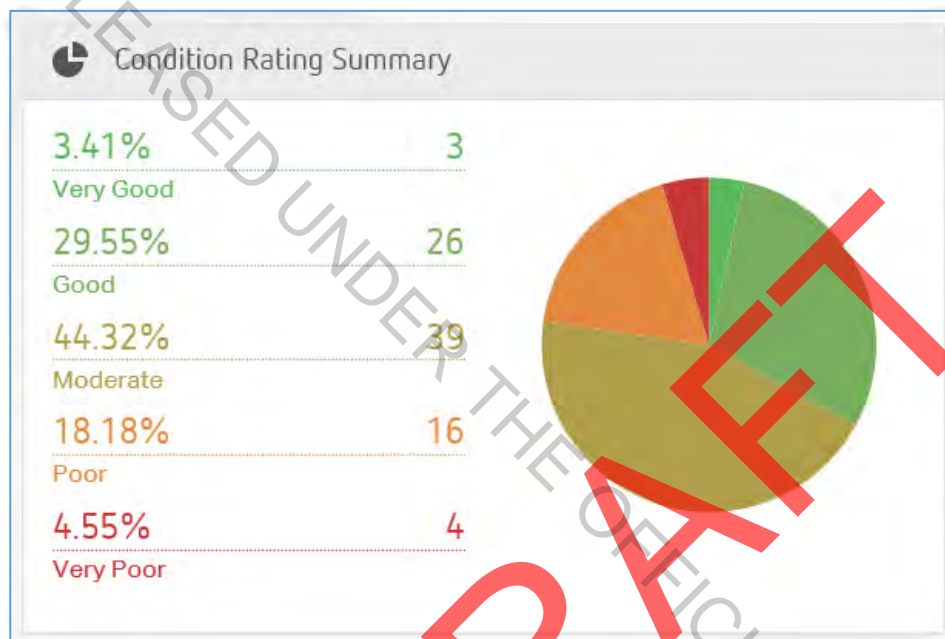
Figure 53 Building 10 Overall Condition

The overall condition of the building is rated at 2.7.

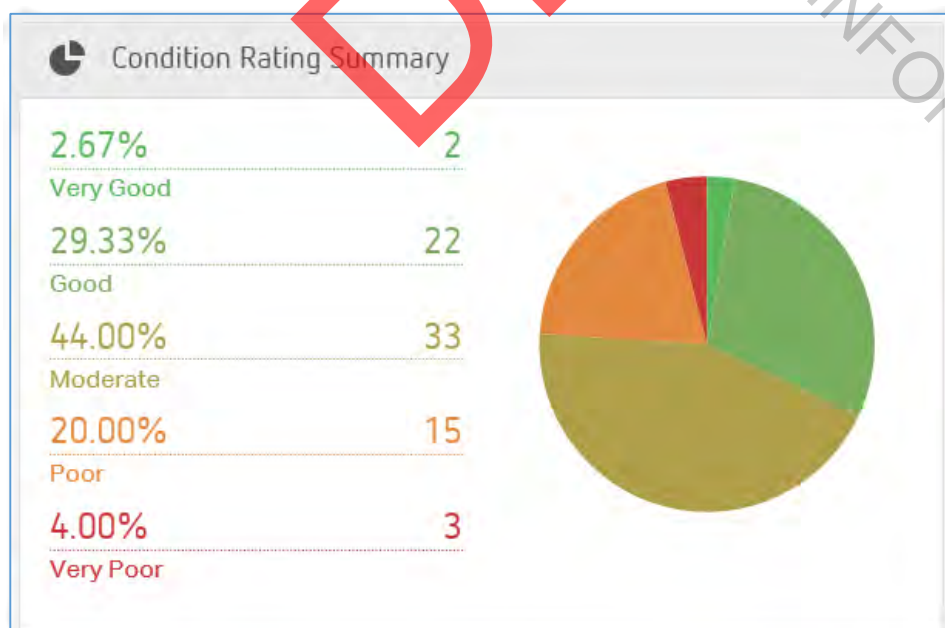
Figure 54 Building 10 Condition of Exterior Elevations

- Patio/Gardens blocking underfloor vents
- Some rot in timber windows
- Shade roof structure appears to be inadequately built
- Step cracks and failed pointing in brickwork, some displaced bricks
- Paint flaking off possible asbestos panels
- Deck boards failed

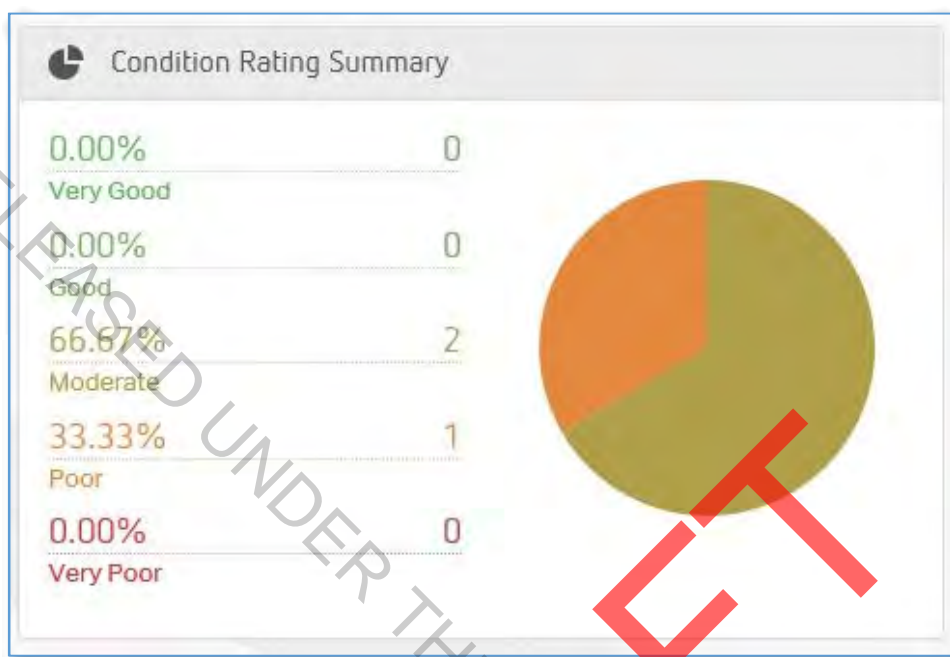
Figure 56 Building 10 Condition of Electrical Systems

The main switchboard for Building 10 is situated in the Laundry. It consists of modern switchgear and equipment but is in moderate to poor condition. One half on the switchboard bi-fold doors is absent.

The distribution switchboard servicing the building consists of modern switchgear and equipment, which is in moderate condition.

The main switchboard and distribution switchboard be replaced in 10-15 years.

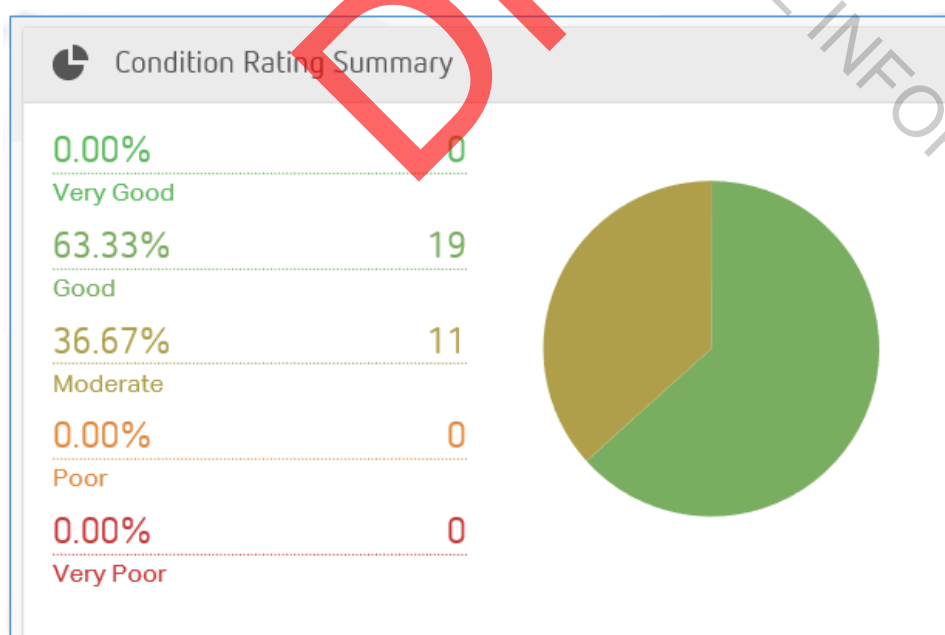
Figure 58 Building 13 Condition of Exterior Elevations

No specific deferred maintenance items were noted during the survey.

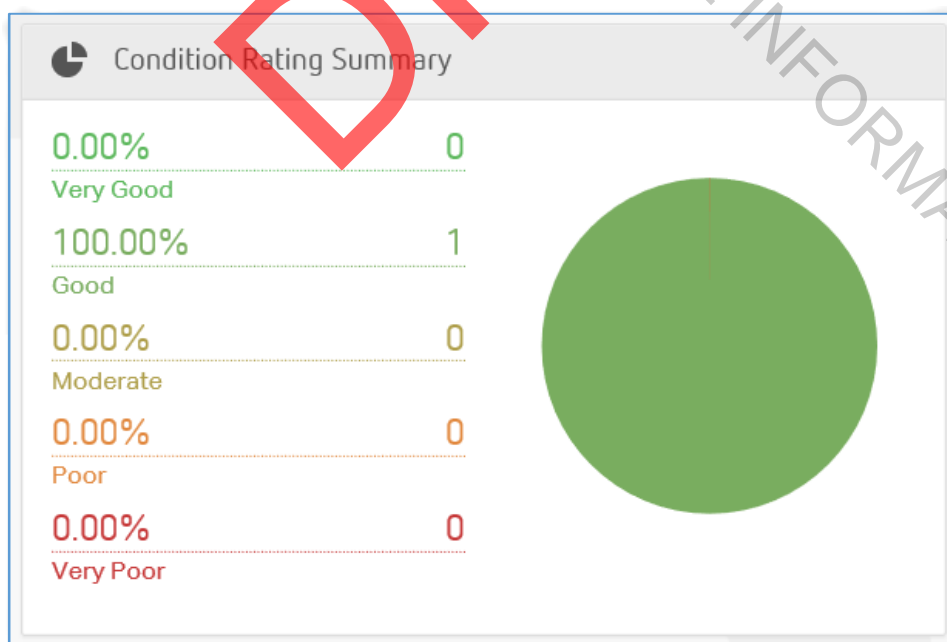
Figure 60 Building 13 Condition of Mechanical Systems

The heating plant for Building 13, Meeting Rooms 3 and 4 is provided by split system heat pumps with natural ventilation via opening windows.

The split system heat pumps are in the second half of service life and should be monitored closely for deteriorating performance and replacement should be planned for within a five year time frame.

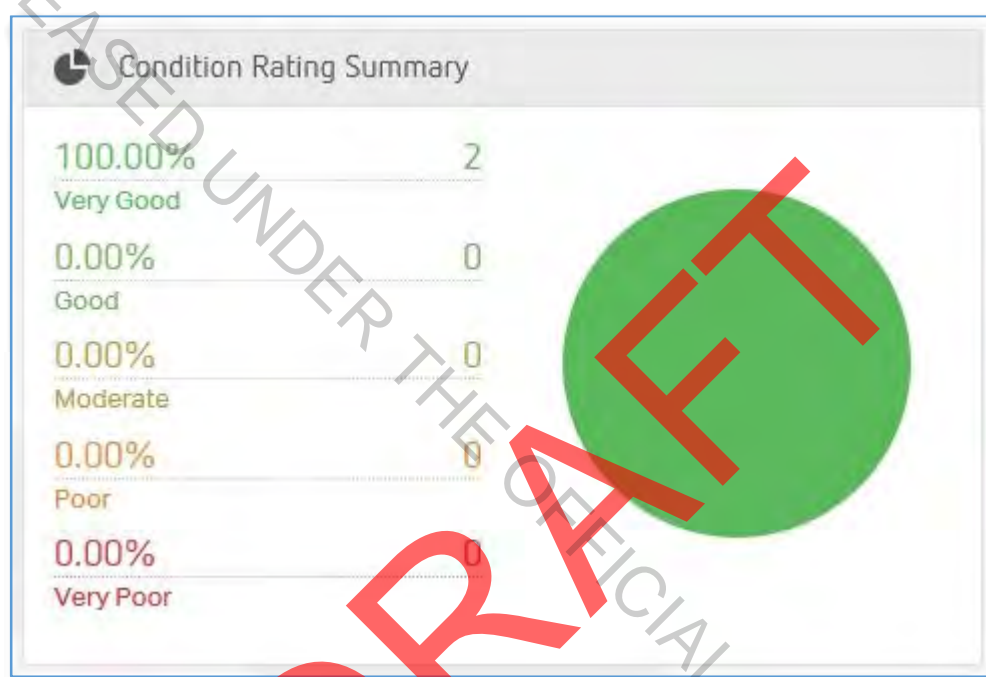
Figure 61 Building 13 Condition of Electrical Systems

The distribution switchboards servicing Meeting Rooms 3 and 4 in building 13 are in good condition with modern switchgear and equipment.

The distribution switchboards be replaced in 15-20 years.

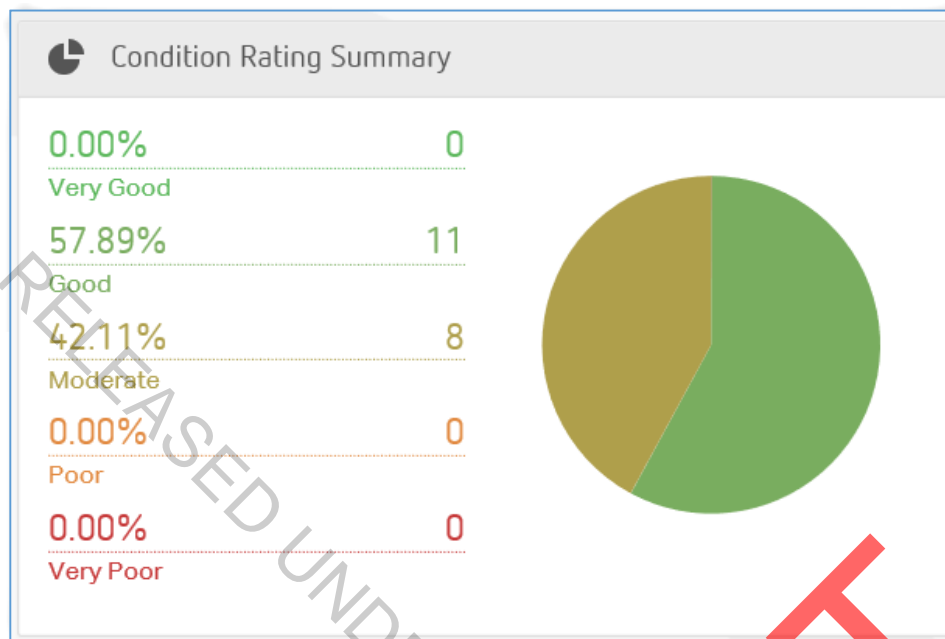
Figure 65 Building 9 Condition of Mechanical Systems

Site reticulated heating water is circulated through a plate heat exchanger to generate low temperature heating water for the building comfort heating and domestic hot water. Heating water is pumped to four heating zones throughout the building.

The mechanical heating plant is generally in good condition, much of it appearing to have been retrofitted recently and while the calorifiers are in the second half of their service life the remaining service life of the facility would be a minimum of ten years.

The chiller, chilled water pumps and the air handling plant are at the end of their service life and should be monitored closely for deteriorating performance and replacement should be planned.

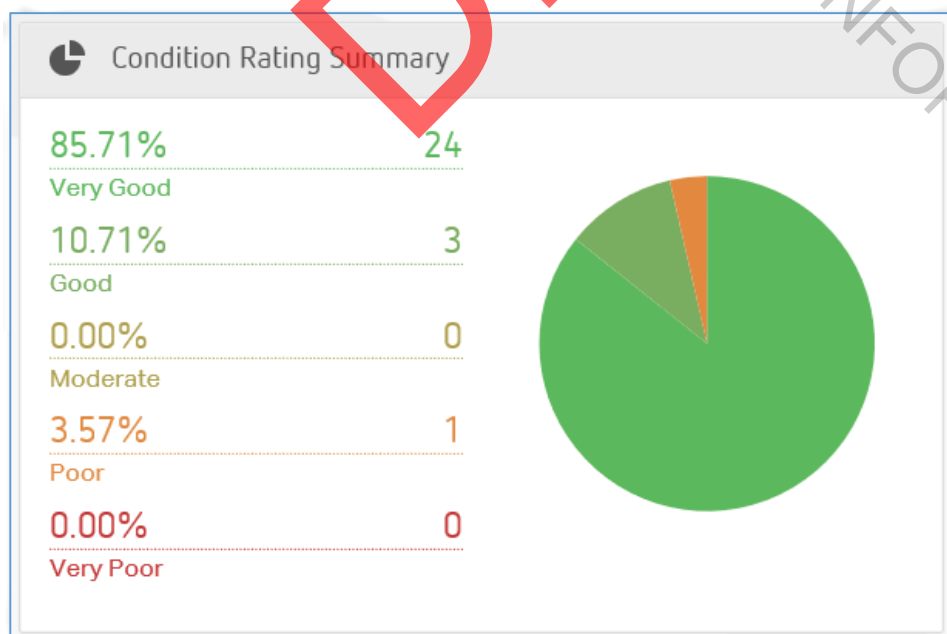
Figure 68 Building 16 Condition of Exterior Elevations

- Failure of sealants on cladding
- Damage to barge boards

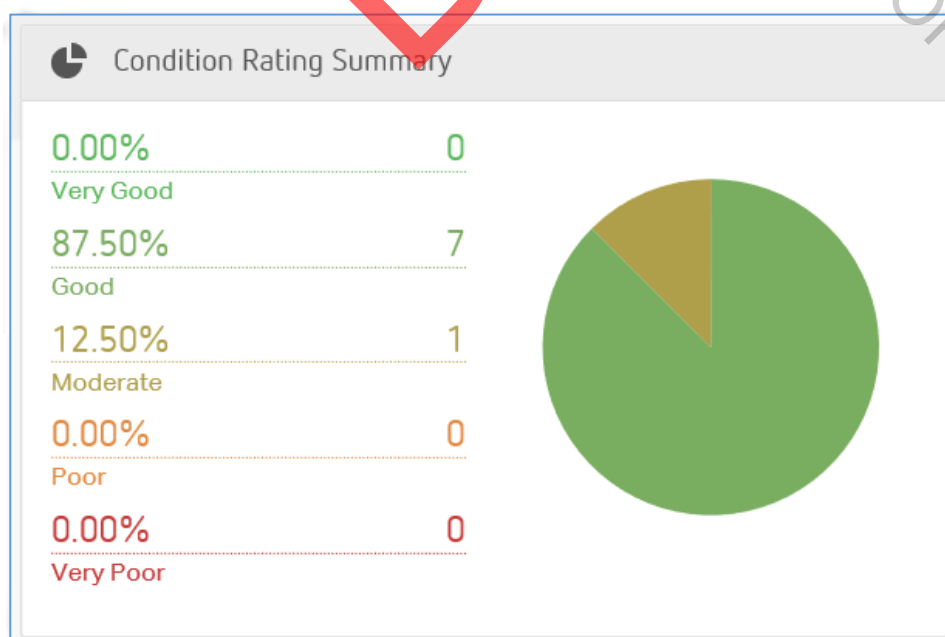
Figure 70 Building 16 Condition of Mechanical Systems

The heating plant for Building 16 is provided by split system heat pumps with natural ventilation via opening windows with some spaces extracted.

The split system heat pumps are in the second half of service life and should be monitored closely for deteriorating performance and replacement should be planned for within a five year time frame.

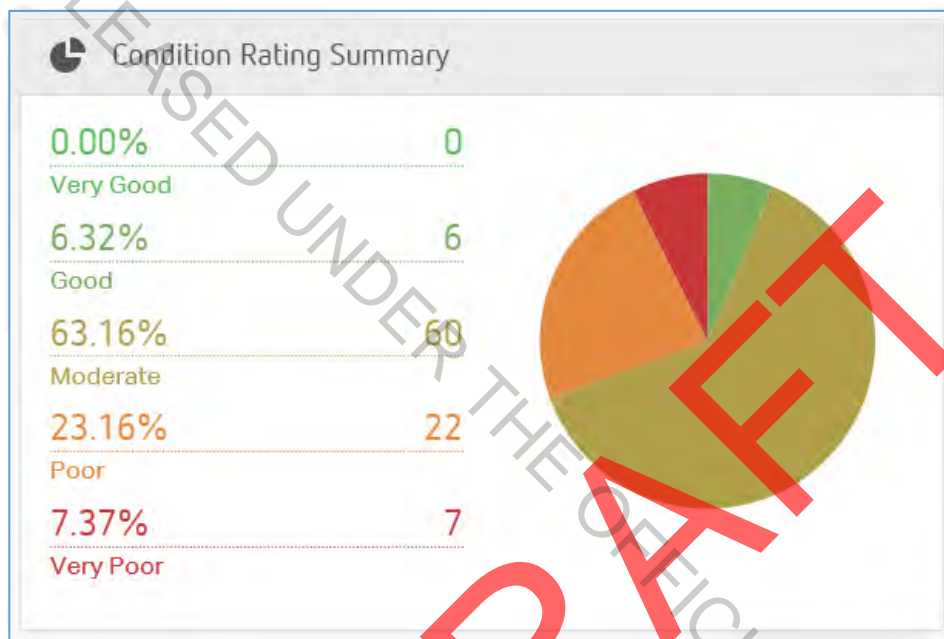
Figure 72 Building 21 Overall Building Condition

The overall condition of the building is rated at 3.2.

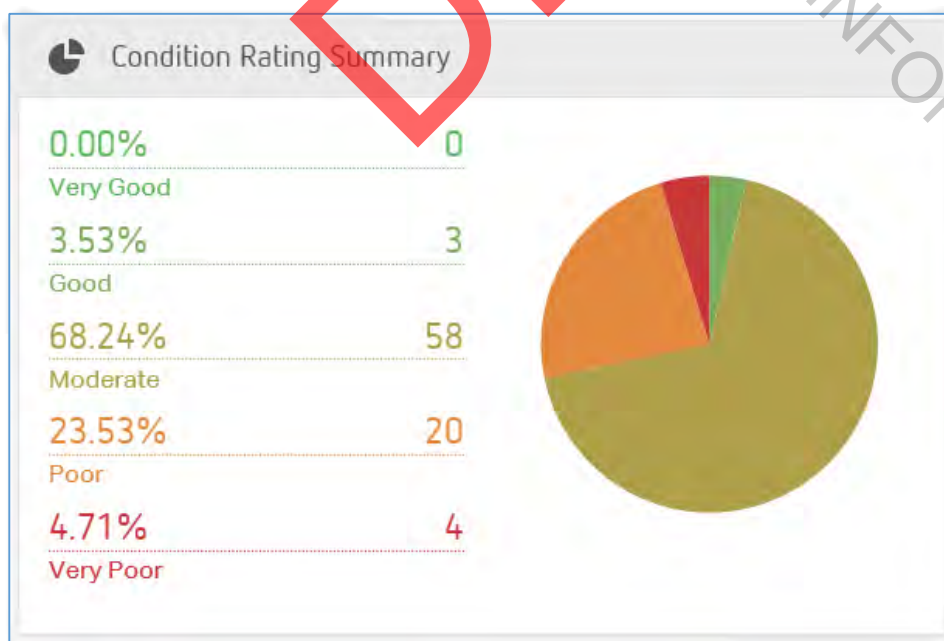
Figure 73 Building 21 Condition of Exterior Elevations

- Heavy build-up of tree debris next to building
- Cladding paint peeling
- Downpipes in poor condition
- Cracks noted in soffits
- Rot in timber flashings around windows

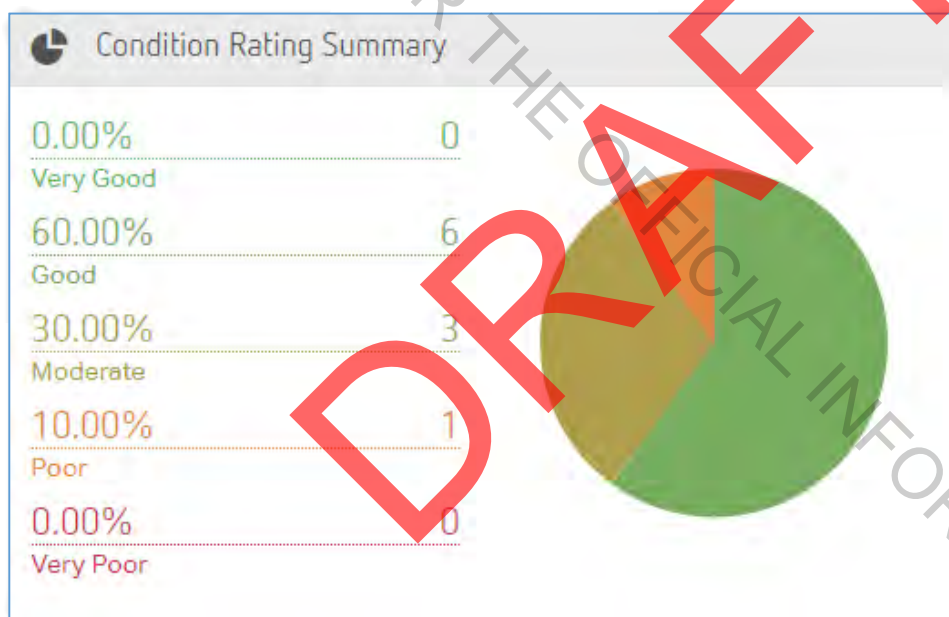
Figure 80 Building 22 condition of mechanical systems

The heating plant for Building 22 is situated in the Calorifier Room. The system includes a modern condensing gas boiler supplying heating hot water, replacing site-reticulated heating water as the energy source. The boiler, expansion tank and circulation pumps for comfort heating, calorifier heating and for domestic hot water circulation have been replaced in recent years and are in the first half of their service lives. The domestic hot water calorifier and control valves are original plant and are nearing the end of their service lives. The heating control panel which includes pump controls and heating zone controls is of the same vintage.

The controls equipment should be replaced when the main switchboard and distribution switchboards are replaced within five years. The calorifier should be replaced within a similar time frame.

The boiler and circulation pumps should have an expected remaining service life of ten years.

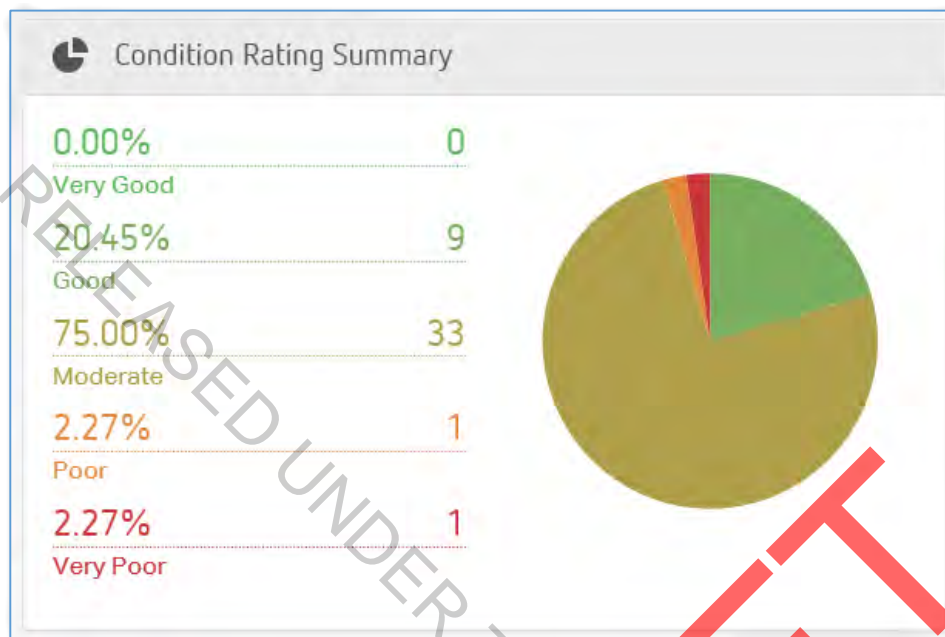
Figure 85 Building 23 Condition of Mechanical Systems

While some systems have been recently retro-fitted and have long remaining service lives, much of the plant is well into the latter end of its useful service life.

Ventilation plant including air handling and evaporative chillers located on level four of the laundry appears similarly to be nearing the end of its economic service life.

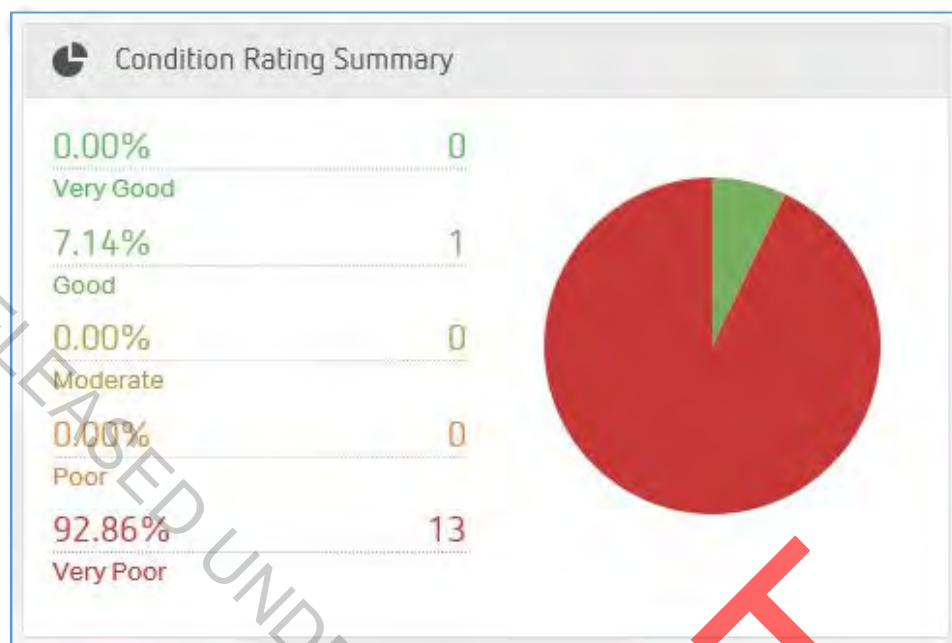
Figure 86 Building 23 Condition of Electrical Systems

The distribution switchboards and mechanical controls boards servicing Building 23 are of the same age as the main switchboard and similarly, a replacement should be considered.

The exception is distribution switchboard DB-4, which is in good condition with modern switchgear and equipment.

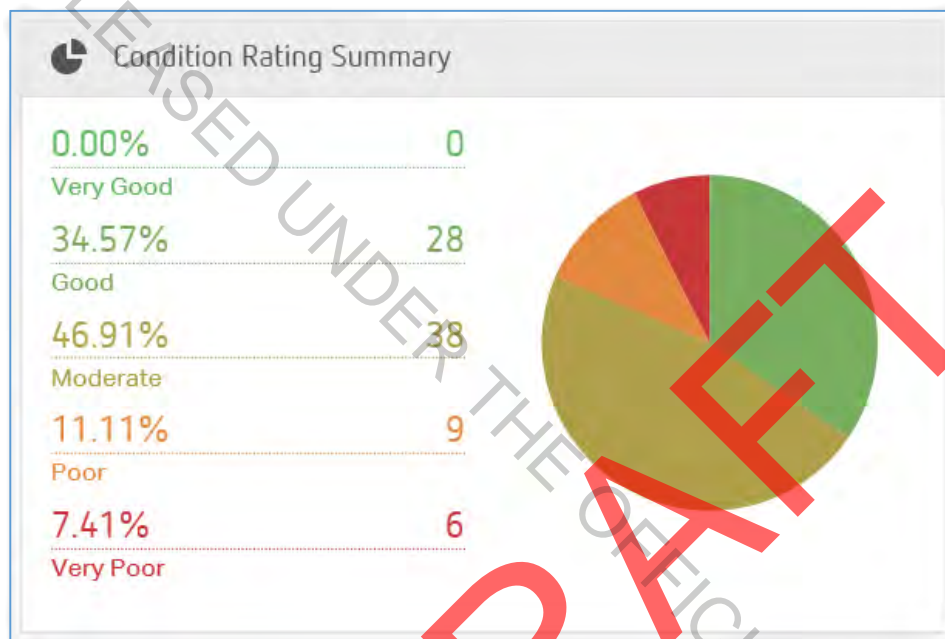
Figure 87 Building 31 Overall Building Condition

The overall condition of the building is rated at 2.5

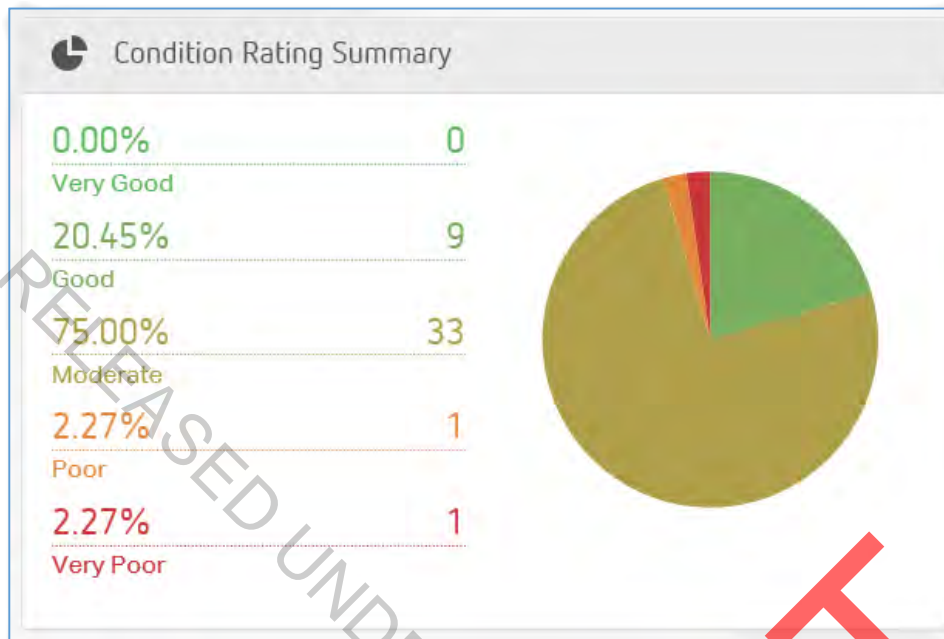
Figure 90 Building 31 Condition of Mechanical Systems

The heating plant for Building 31 is in the services basement spaces. Steam from the central heating plant is reticulated to the building and distributed to the kitchen. The plant is at or nearing the end of its useful service life.

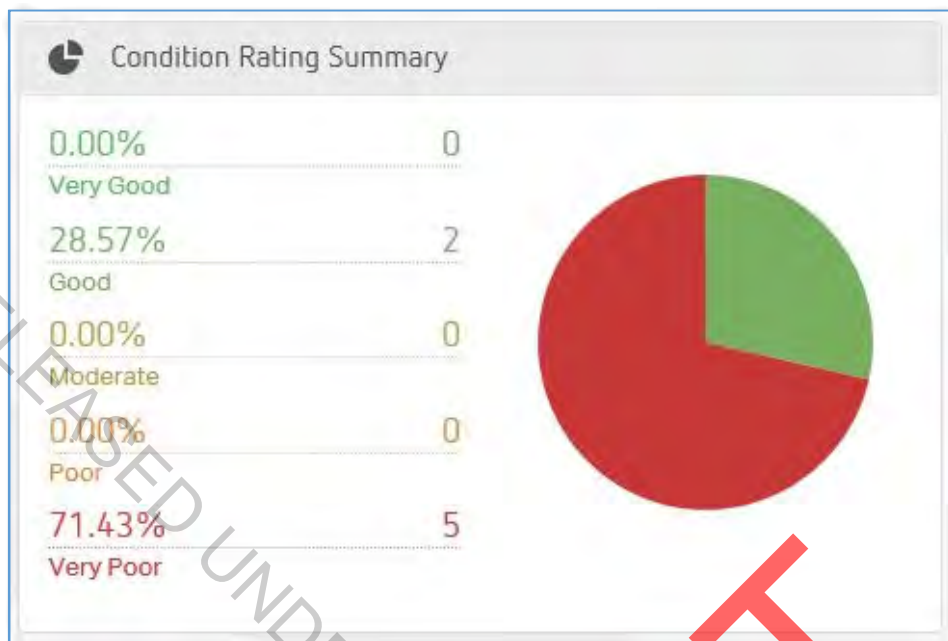
Figure 91 Building 31 Condition of Electrical Systems

The distribution switchboards and mechanical controls boards servicing Building 31 are of the same age as the main switchboard and similarly, a replacement should be considered.

The exceptions are distribution switchboards DB-1E in the Plant Room and DB.5 in G023, which are in good condition with modern switchgear and equipment.
