### **RE Official information request WCDHB 9438**

# Grey Base Hospital Acute and Community Mental Health Detailed Seismic Assessment

Project Number: 5-C4202.00  
22 June 2020

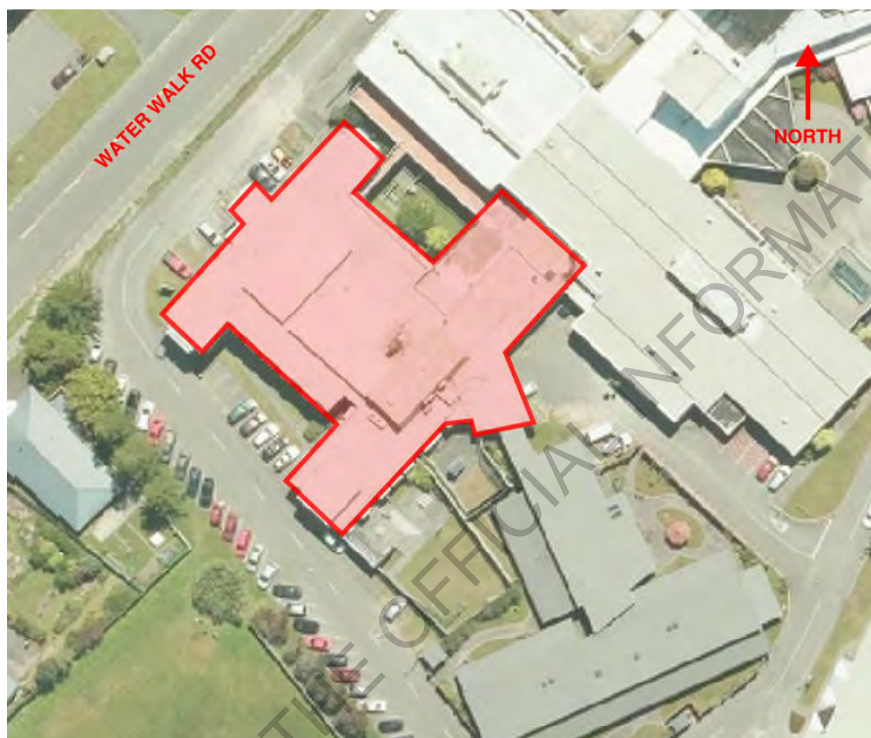
Figure 1: Aerial image of the building

The Grey Base Hospital Acute and Community Mental Health Services building is a two-storey reinforced concrete frame and wall building with internal timber framed upper floor walls and roof structure. Structural drawings for the building are dated November 1977 and the building is believed to have been constructed circa 1978 to 1980. The layout of the timber walls in the upper level of the building was altered in November 2000.

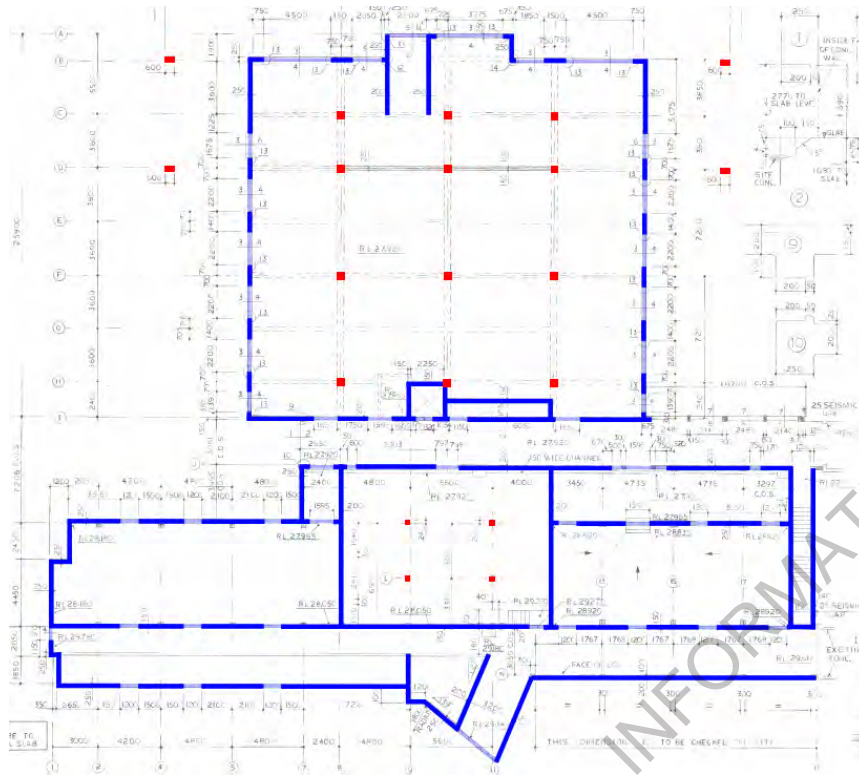
Figure 2: Lower level structural layout

The foundations consist of a continuous strip foundation underneath the RC walls and individual pad footings underneath individual columns. Pad footings are linked together with concrete ground beams.

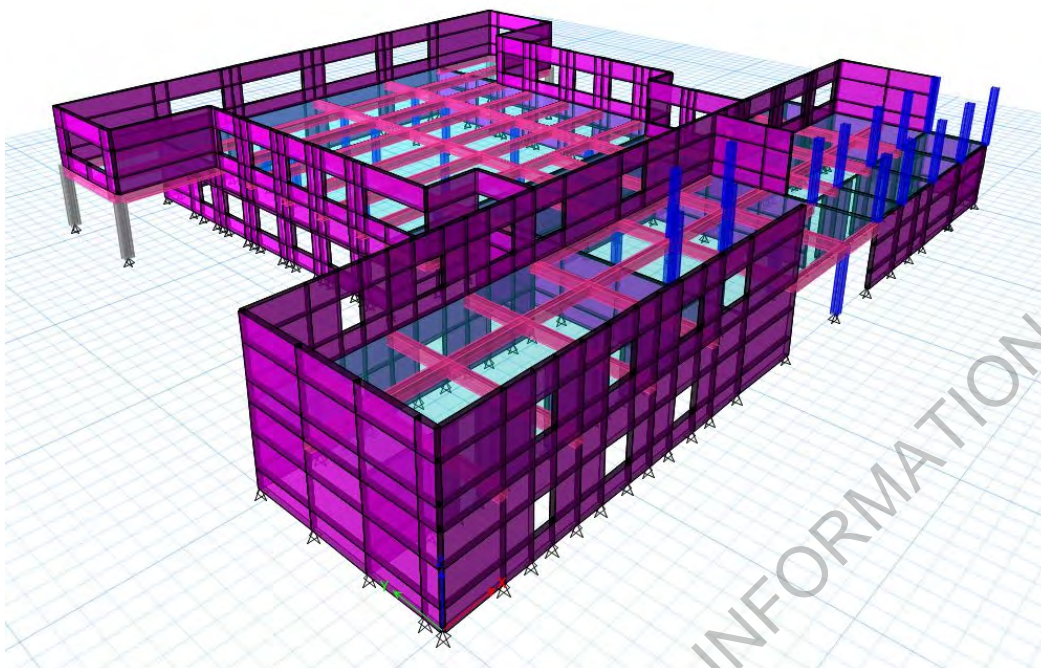
Figure 4: ETABS model of structural system

ETABS building design software (V17) was used to assess the building response. Axial, bending and shear demands at ultimate limit state (ULS) were extracted from the model and compared with section capacities to determine the percentage New Building Standard (%NBS). An image of the model used is shown in Figure 4.

The lateral deflection of the structure under the design seismic event was found to be minimal due to the large volume of walls around the full perimeter. The deflections are less than the 25mm gap provided to the neighbouring building. Therefore, pounding is not expected, however, the deflection profile of the neighbouring building is unknown. The fundamental period of the building was found to be 0.05 seconds, which demonstrates the rigidity of the structure.
