RE Official information request WCDHB 9505

Grey Base Hospital Acute and Community Mental Health Detailed Seismic Assessment

Project Number: 5-C4202.00
30 April 2020

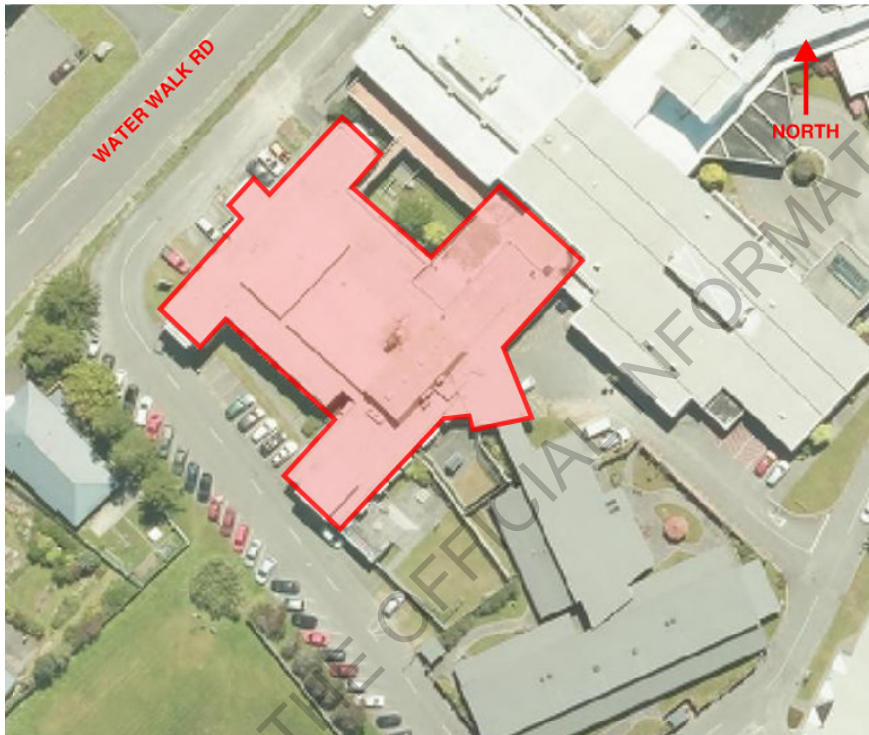
Figure 1: Aerial image of the building

The Grey Base Hospital Acute and Community Mental Health Services building is a two-storey reinforced concrete frame and wall building with internal timber framed upper floor walls and roof structure. Structural drawings for the building are dated November 1977 and the building is believed to have been constructed circa 1978 to 1980. The layout of the timber walls in the upper level of the building was altered in November 2000.

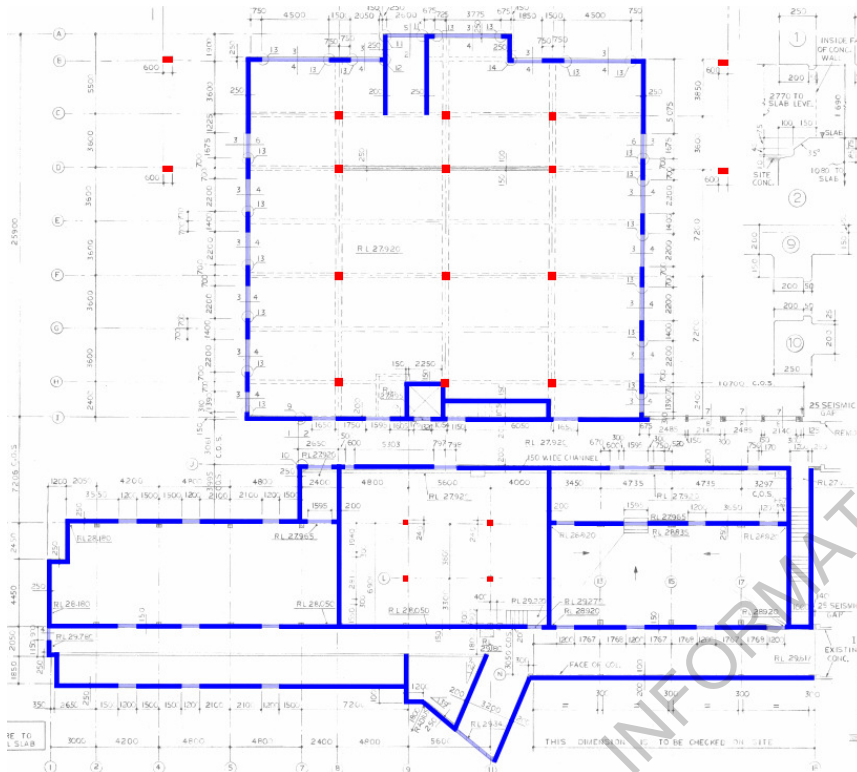
Figure 2: Lower level structural layout

The foundations consist of a continuous strip foundation underneath the RC walls and individual pad footings underneath individual columns. Pad footings are linked together with concrete ground beams.

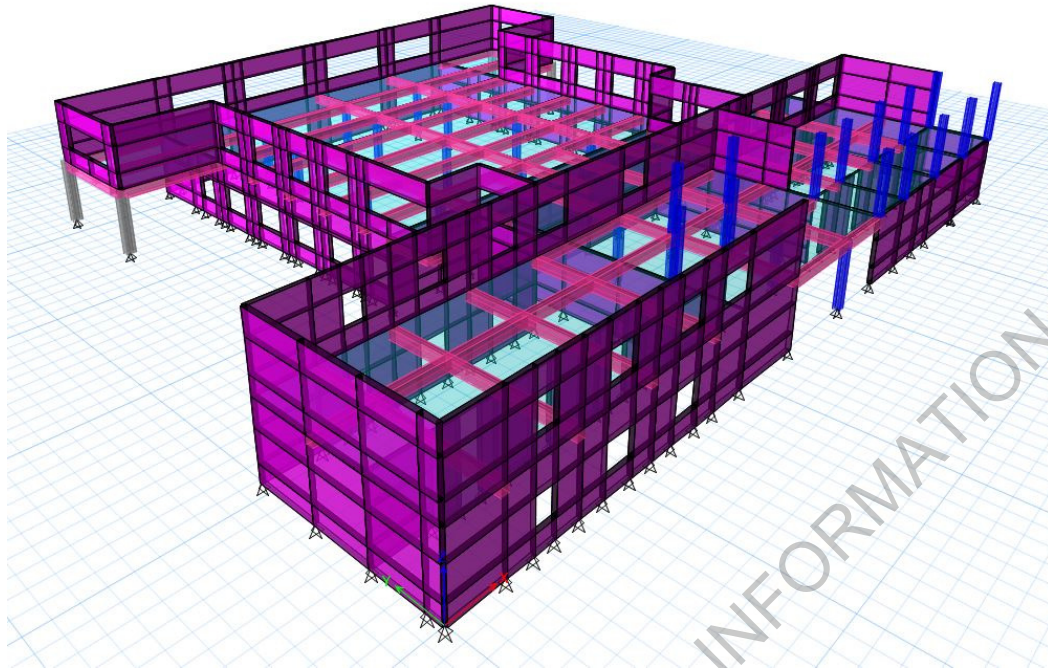
Figure 4: ETABS model of structural system

ETABS building design software (V17) was used to assess the building response. Axial, bending and shear demands at ultimate limit state (ULS) were extracted from the model and compared with section capacities to determine the percentage New Building Standard (%NBS). An image of the model used is shown in Figure 4.

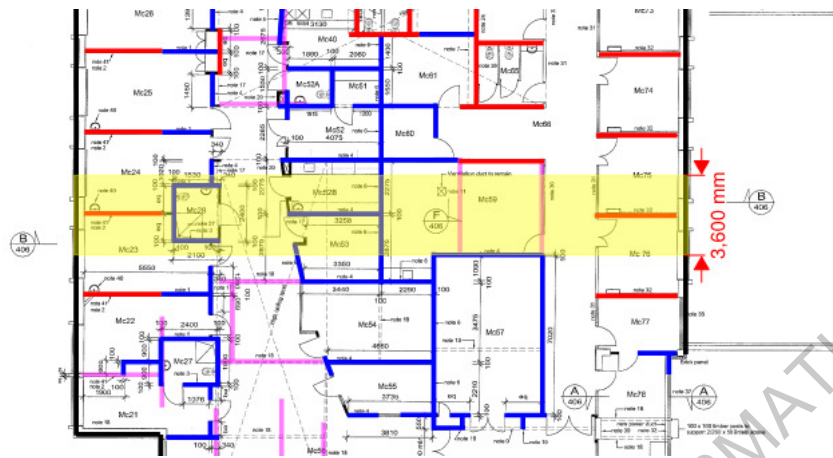
Figure 7: Strip of upper level assessed

The force-based approach to assessing the walls considered the weight supported by the timber walls and ignored the concrete perimeter walls contribution and weight. Using a ductility factor of $\mu=3$ and a structural performance factor of $S_p=0.7$, the timber walls had a minimum rating of 55% NBS (IL3) in the critical direction.

In order to determine the combined response of the timber walls acting in conjunction with the concrete perimeter walls, a SLaMA assessment was undertaken to verify this result. This looked at a critical tributary strip of the upper level of the structure.

The predicted acceleration-displacement responses of the concrete walls and timber walls are shown below. When plotted with the ADRS curve the resulting rating is slightly higher, at 60%NBS (IL3), than the force based assessment when comparing the capacity to the ULS elastic ADRS curve.

In order to achieve a seismic rating greater than 67%NBS (IL3), it is recommended to reline a selected amount of wall area with a material that contains a larger bracing capacity such as GIB Braceline and/or plywood.
